Metro West – The Bays

FINAL Revised Archaeological
Research Design and Excavation
Methodology

Report to AFJV / Sydney Metro

November 2021

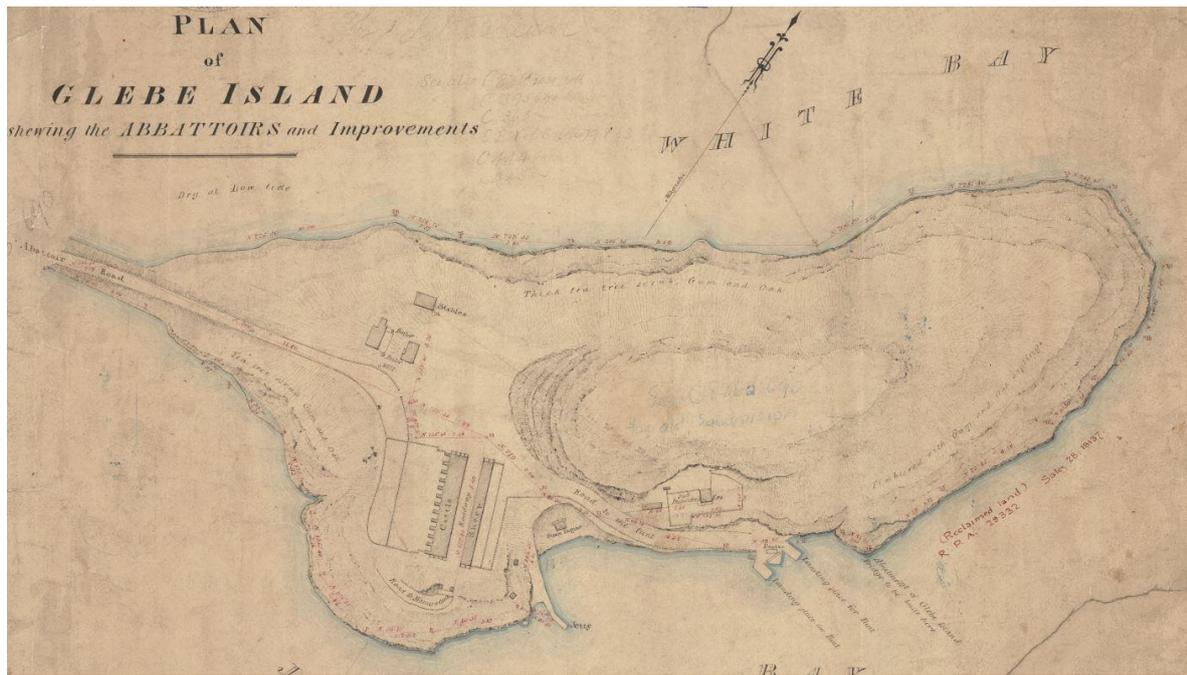
Figure 9: "Plan of Glebe Island showing the Abattoirs and Improvements," 1860. Source: NSW LRS, Crown Plan 826-690

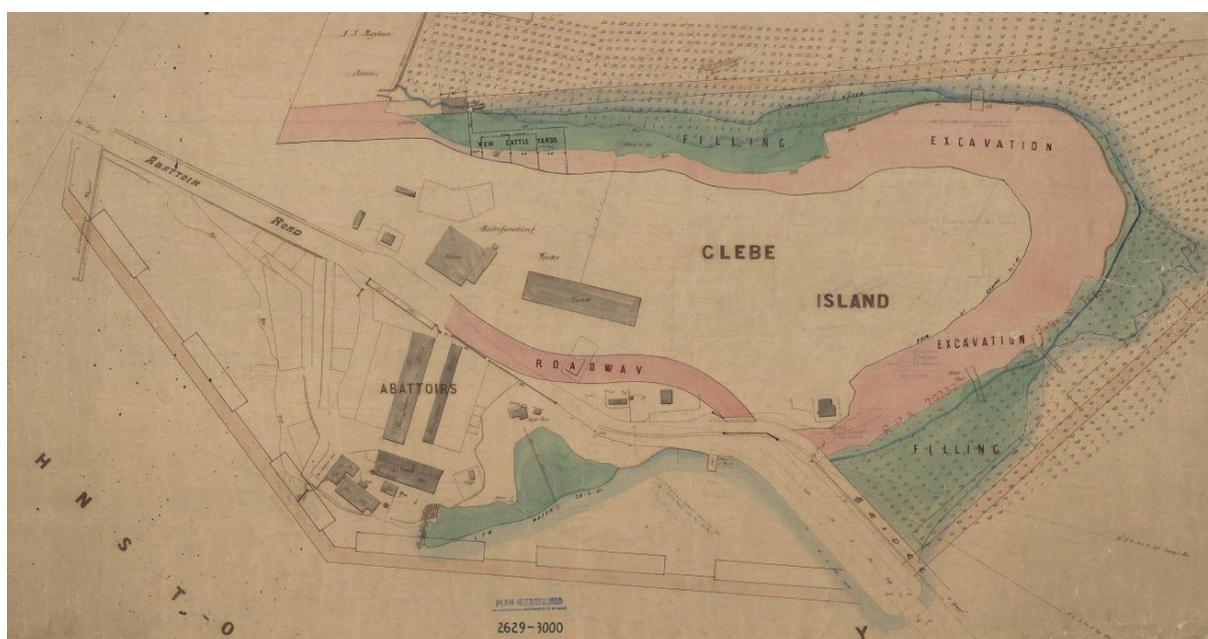
Figure 14: Plan for proposed wharfage accommodation at Glebe Island, dated March 1899, showing the Glebe Island Abattoirs after extensions, including the refrigeration works and cattle wharf. Excavation areas are shaded pink, and infill areas are shaded green. The realignment of Abattoir is also noted in pink. Source: NSW LRS, Crown Plan 2629-3000

Several leases for quarrying were noted in pencil along the eastern portion of the island, likely as later annotations in relation to the 1910s wharfage. The 1899 plan shows several areas as "excavated," while other areas were flagged for 'filling', including near the Glebe Island Bridge, where a new alignment for the Abattoir Road was noted. The refrigeration works were noted as 'store', and there were several buildings located nearby, including a cottage.

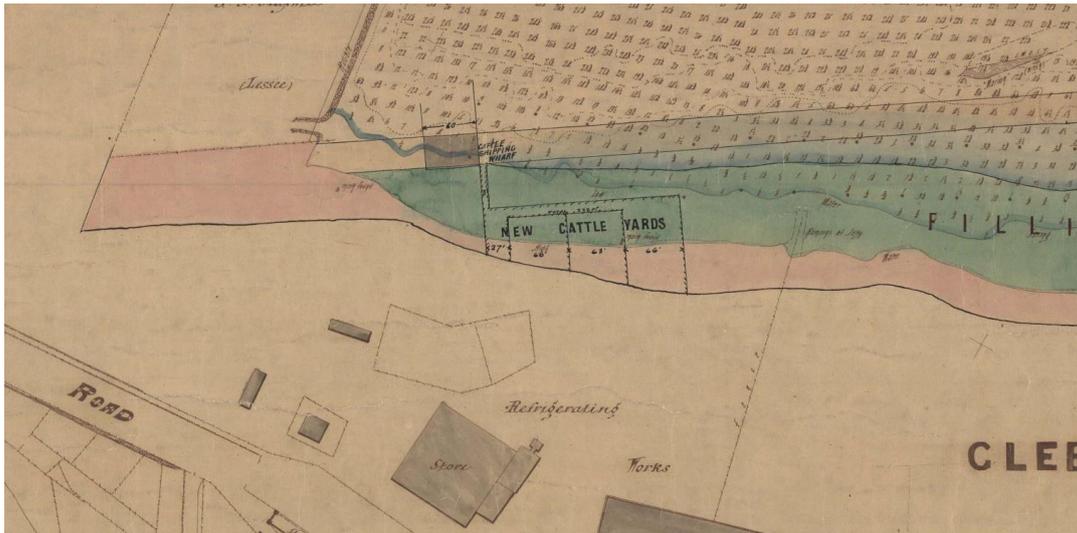
Figure 15: Detail from 1899 Crown Plan, showing the Cattle Wharf and adjacent “new cattle yards” at White Bay. A fence is noted, leading from the vast tank of the refrigeration works to the “remains of jetty” beyond the high water mark. Source: NSW LRS, Crown Plan 2629-3000

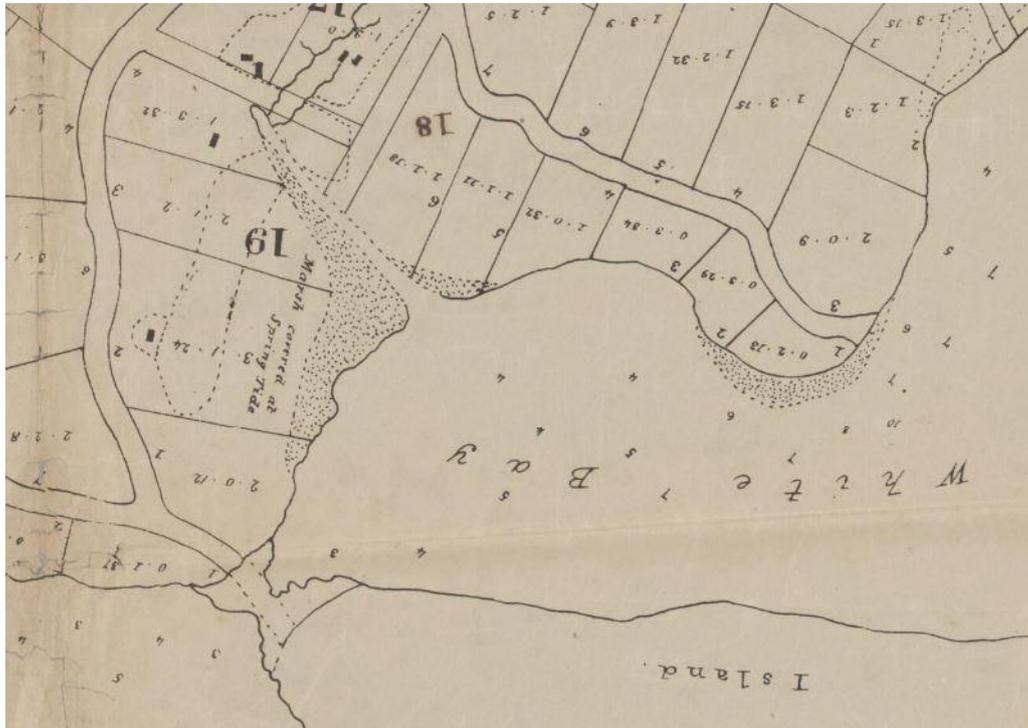
Figure 17: Plan of Balmain Estate, 1852. Source: NLA, Map F535⁸⁶

There are numbers drawn in White Bay and these are likely to depth soundings although it is not stated on the map. It is assumed that they are in feet. Assuming a tidal range of 3.3feet (2m) it seems likely that the bay at this time was still covered with water even at low tide.

Street on allotment 2, as the only building in the immediate area (Figure 17). A further building was located on allotment 4 further north. The plan shows the situation prior to 1867, when Crescent Street, from Parsons Street to Abattoir Street, was aligned.⁸⁵

The 1874 plan shows that much of White Bay was low lying mud flats exposed at low tide. This is a different situation from the earlier plans especially Figure 17 which shows 3-4 foot of water at presumably high tide. In 1874 the low tide mark is 230m from high water mark in the south and 290m in the north.

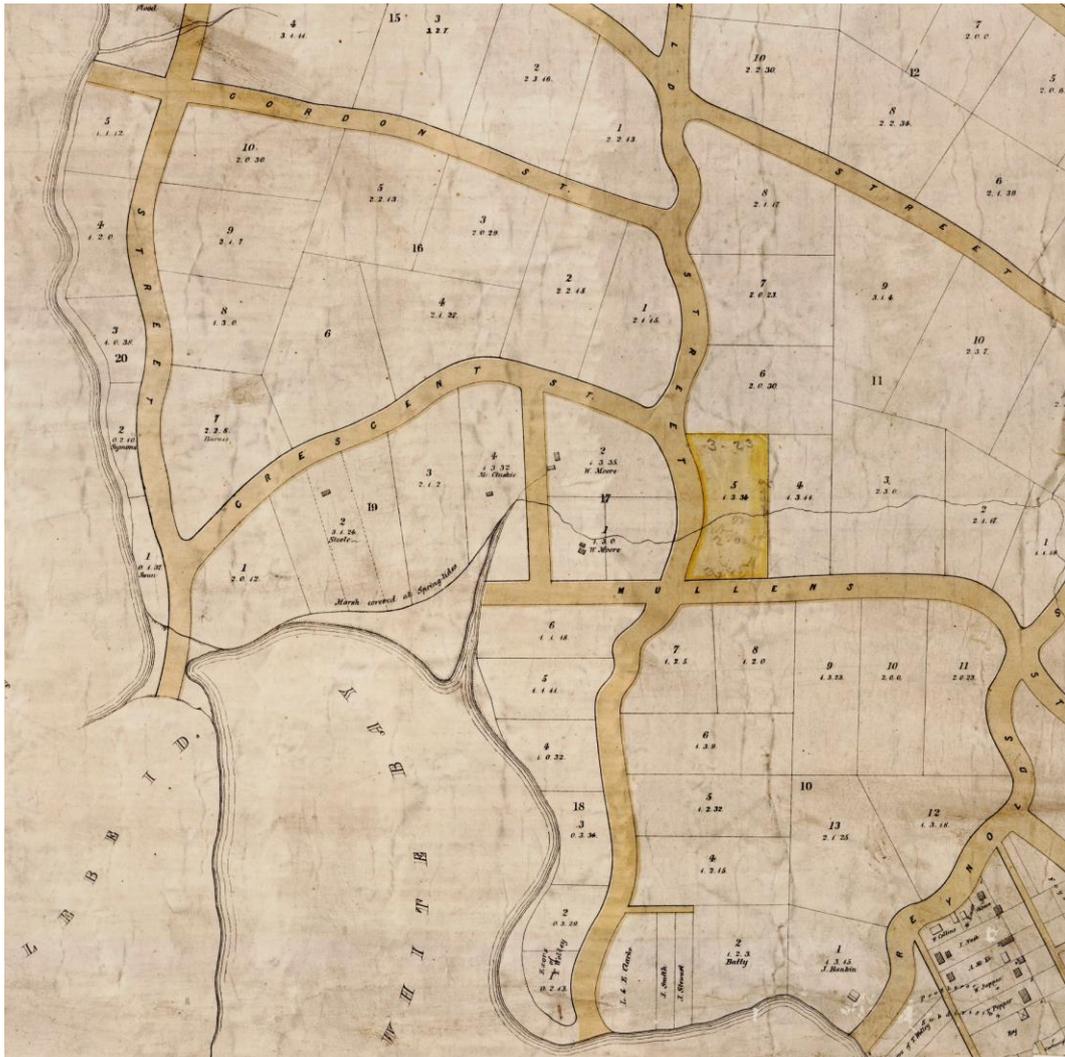
Figure 18 Detail from Plan of Balmain Estate 1852 (source State Library)

A later plan of Balmain from 1861 shows the same area (Figure 18).⁸⁷ This plan again shows building on Lots 2 and 4 of Section 19 but notably nothing on the site of the first White Bay Hotel. The plan shows the site immediately prior to the sale of the remaining lots in the Balmain Estate in 1862

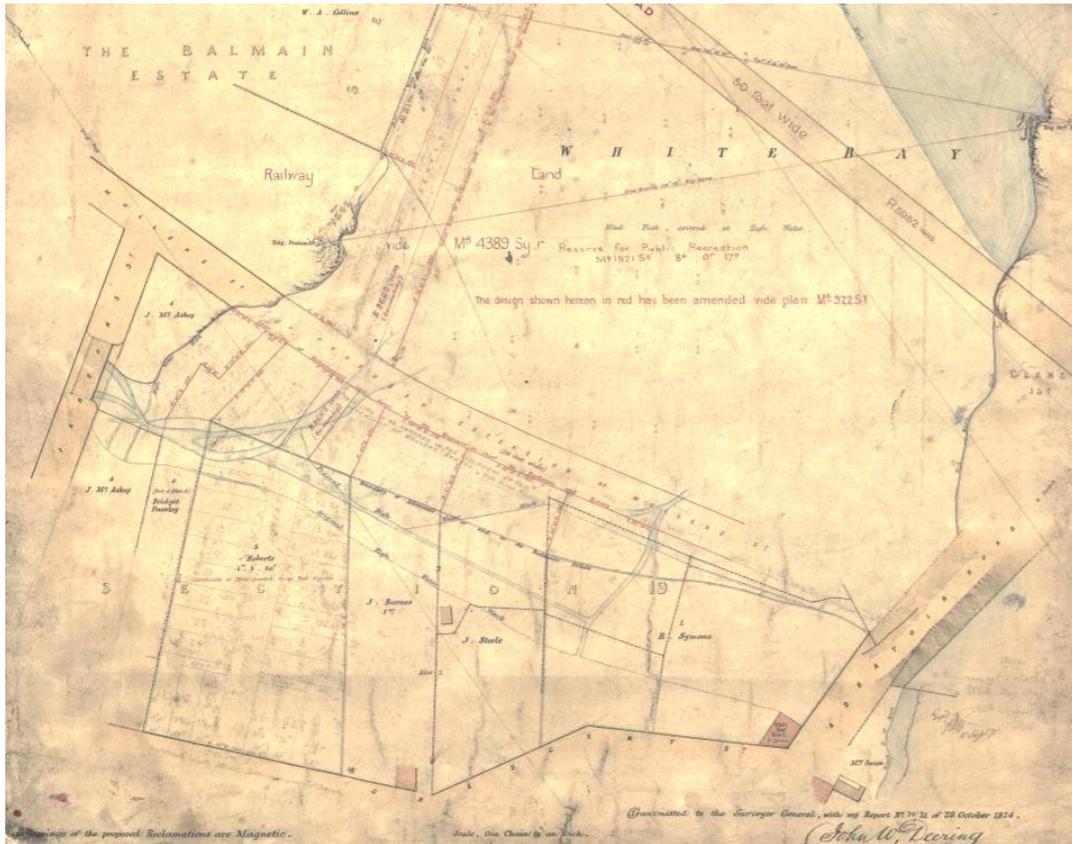
The mud flats to the east of Crescent Street were crisscrossed by water channels connected to a creek in the north and the bay in the east. While the low water mark was located in quite some distance away from the properties on the eastern side of Crescent Street, the original high-water mark ran up to the rear corner of the White Bay Hotel. The high-water mark in 1874, however, was noted a little further to the east, extending past the 'Boundary of Allotments as sold in the Balmain Estate' in a straight line. This evidence suggests that some filling or land reclamation had been undertaken between the 1862 subdivision sale and 1874.

Figure 19: Plan showing proposed reclamation at White Bay dated 1874, showing the location of Robert Symonds' White Bay Hotel and property, with high- and low-water marks noted. The plan contains various later annotations (in red and pencil). Source: NSW LRS, Crown Plan 18-574

A plan transmitted to the Surveyor General on 28 October 1874 (Figure 19) shows that the large corner site bounded by Abattoir Road in the south, Crescent Street in the west (later known as Weston Street), and White Bay in the east, was occupied by Robert Symonds (at that time noted as R. Symons) and his White Bay Hotel. Although the *Sydney Sands Directory* only noted “Simons, Robert, publican, Wide Bay Hotel” [sic] for the first time in 1866, Symonds was already mentioned in the *Sydney Morning Herald* as the publican of the White Bay Hotel, Balmain, by April 1859.⁸⁸ It is possible that this was an earlier hotel of that name, located in a different area of Balmain, or that Symonds had established the hotel at the site prior to the official subdivision sale in 1862.

The source of the sediment is of interest. It seems unlikely that it was erosion from the lots to the west and although the catchment of what has become the Beattie Street drain is quite long it is also narrow and steep sided there is no evidence of a typical alluvial fan on the mudflats. Deliberate filling is a possibility especially as the low water mark is suspiciously straight in Figure 19.

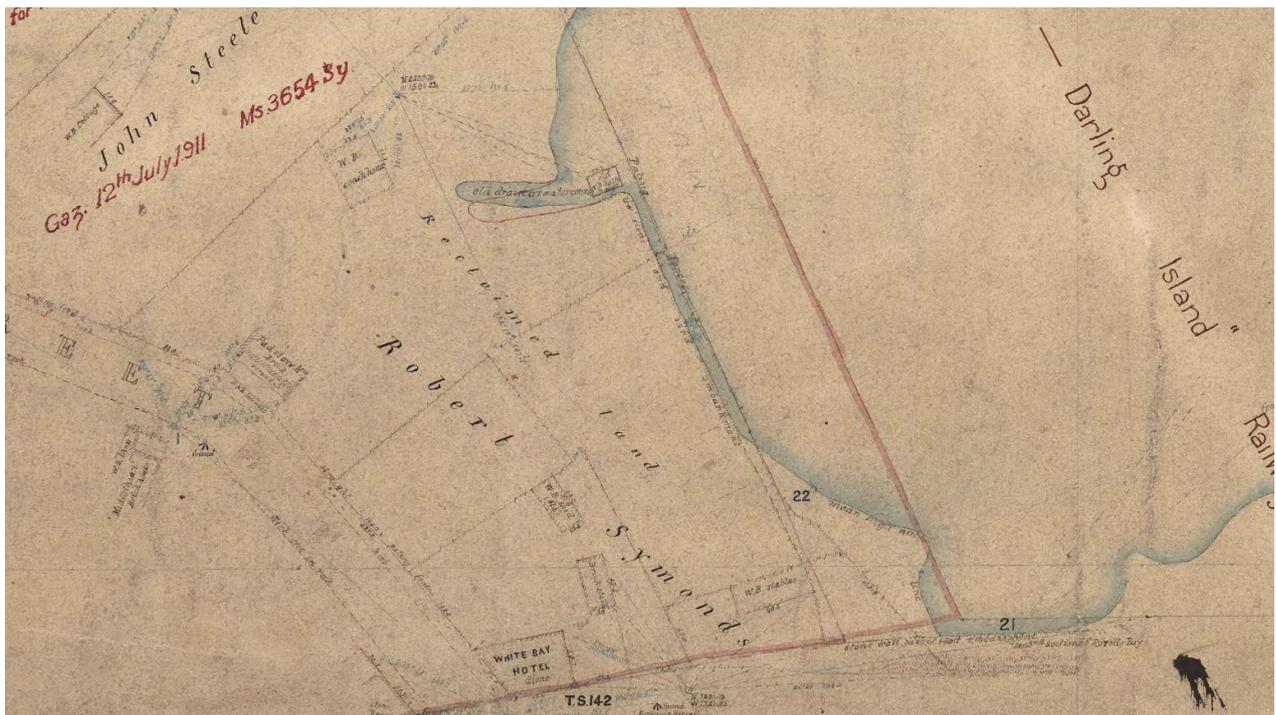
Figure 20: Detail from plan surveyed in mid-1880, showing Robert Symonds' property which contained his White Bay Hotel at the corner of Abattoir Road and Crescent Street, and his residence, Padstow House, further north on Crescent Street. Various stables and sheds were located on the property, as well as an old boat house near the mean high-water mark. Just north of Abattoir Road, to the east of the hotel, were weatherboard stables, and a stone wall marked the base of the road embankment. Source: NSW LRS, CP 106-574

A plan dated 1880 (Figure 20) shows that additional buildings had been constructed by that time, and several areas had been fenced in. The White Bay Hotel, a stone building, occupied the corner of Abattoir Road and Weston Road, and to its northeast there were brick stables and a weatherboard shed, with the latter noted as 'old'. Additional weatherboard stables were located further east along Abattoir Road, still on Symonds' land but closer to the bay, in a separately fenced in area.

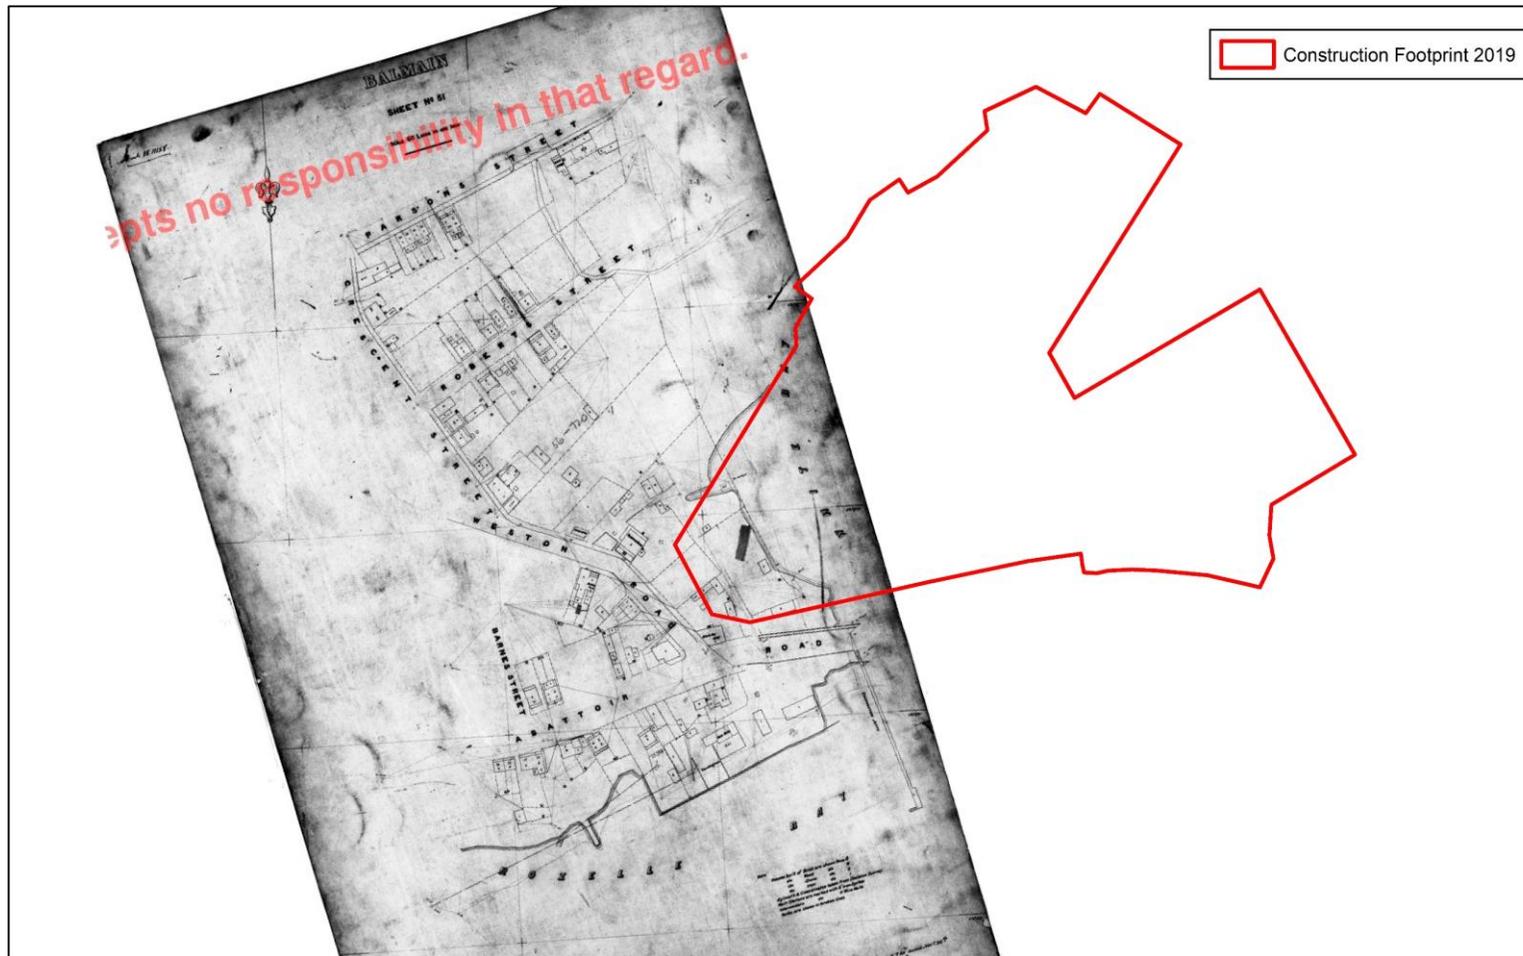
Figure 38: 1852 Plan of Balmain Estate Subdivision Overlay

Historic plans have been overlaid to demonstrate where the locations of former structures and landscapes in Figure 38 to Figure 42 for phase 1.

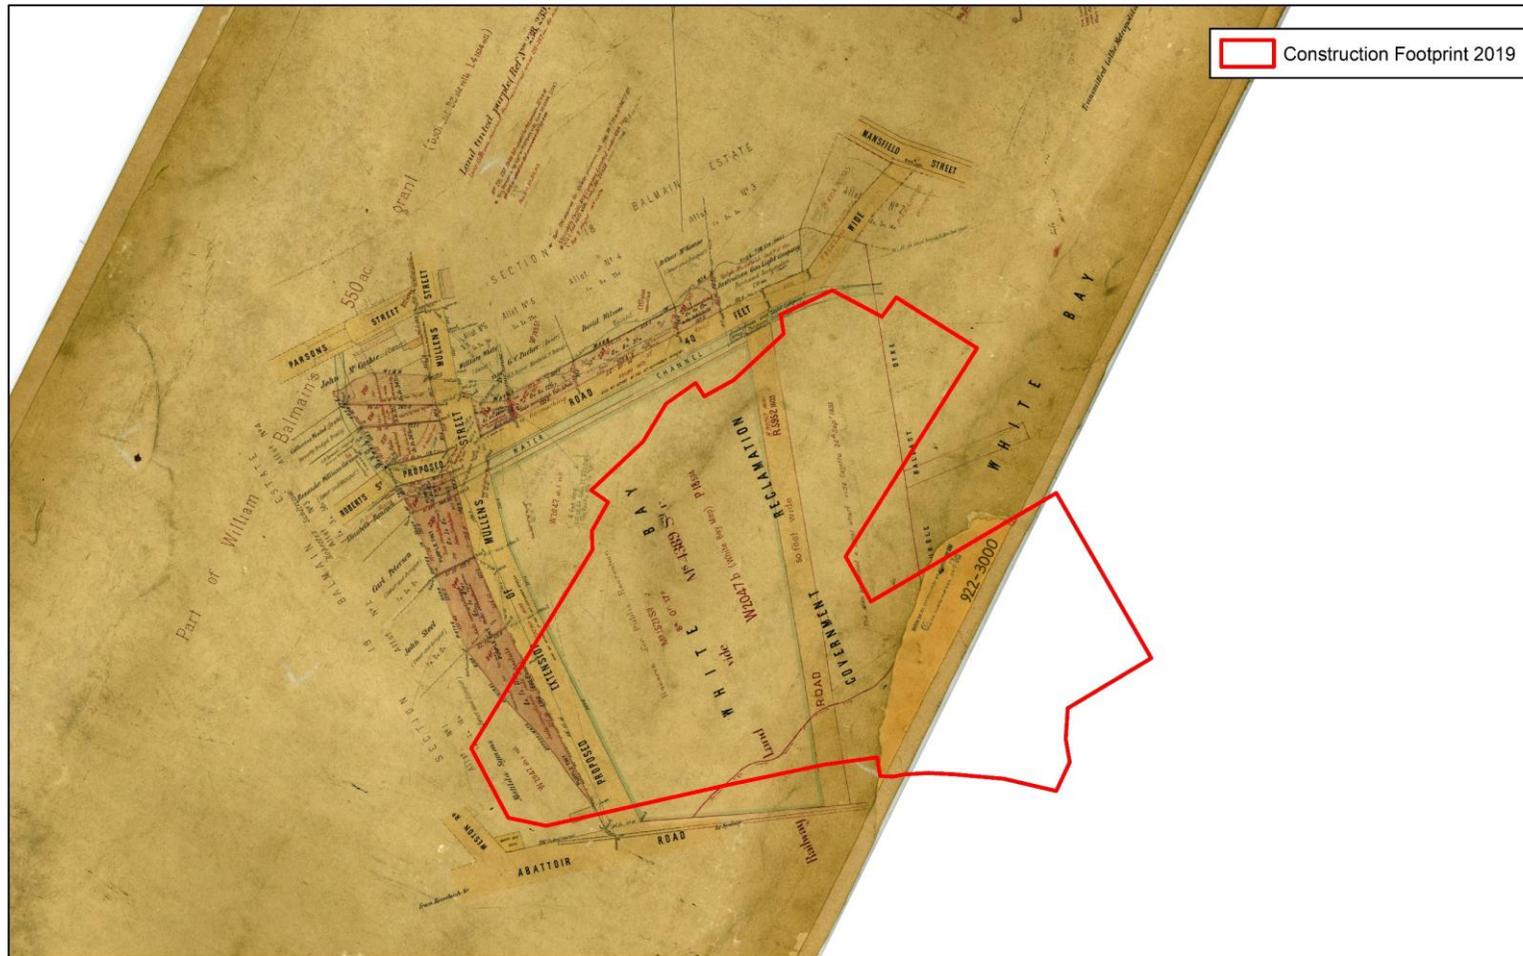
Figure 39: 1888 Sydney Water Plan Overlay

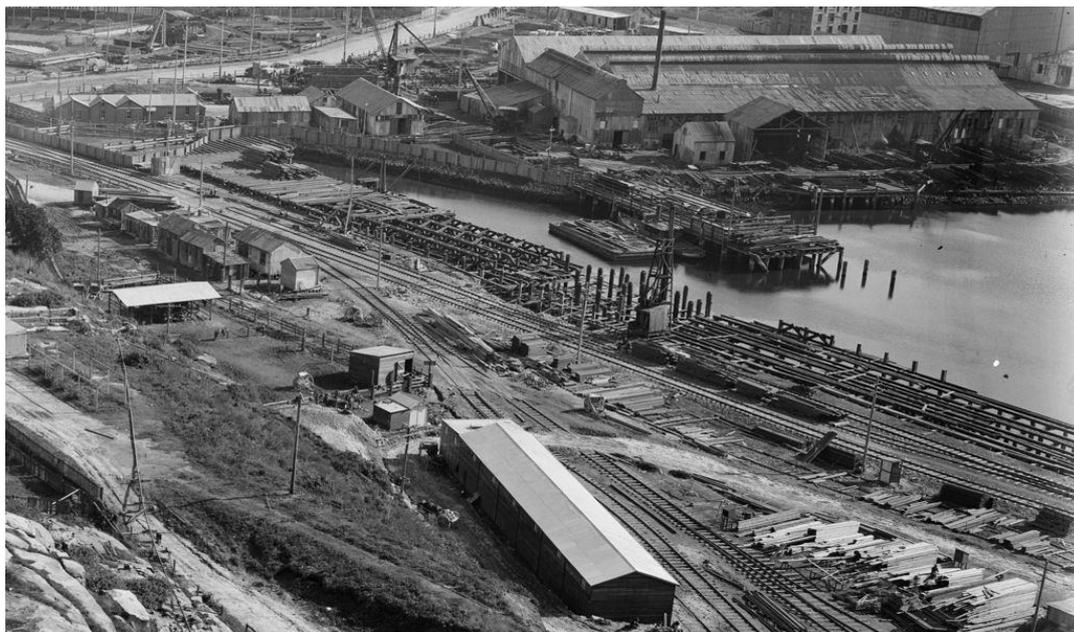
Figure 46: The northern side of Glebe Island, c1919, with the raising of the existing wharves underway. Railway tracks have been laid, and there are various smaller and larger buildings and sheds located alongside the tracks. Source: SLNSW, FL412660¹⁸²

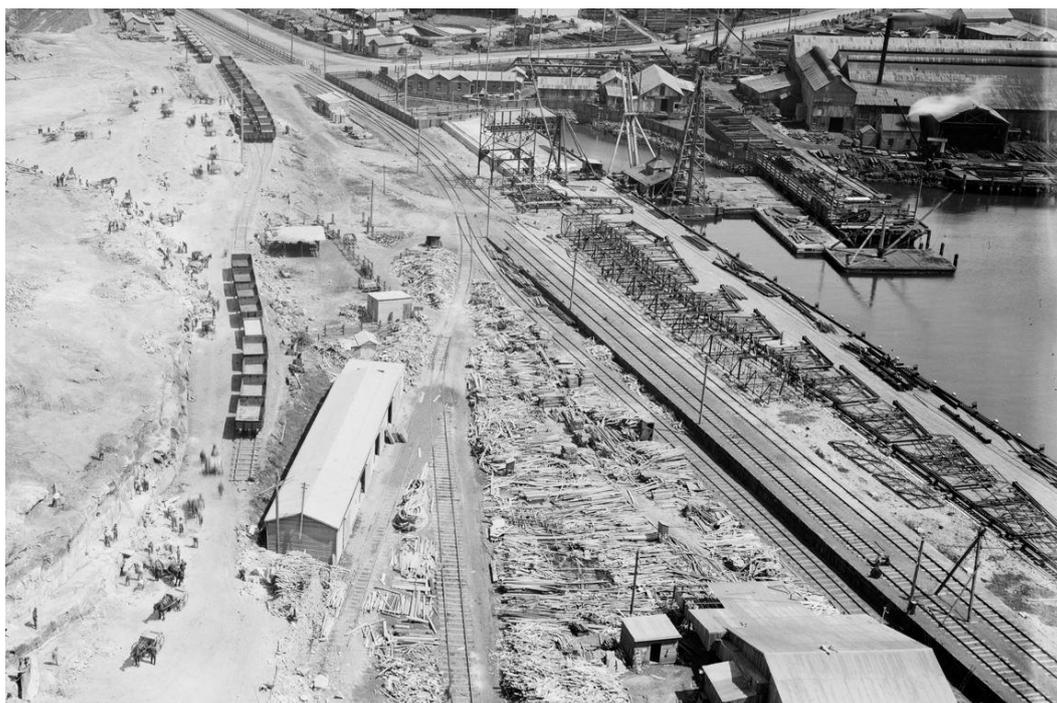
Figure 47: The western end of the Glebe Island wharves, 28 September 1920. The wharves have been raised and the framework for the 'shipping galleries' is ready for construction. Some of the sheds alongside the railway tracks have been removed. Source: SLNSW, FL 412658¹⁸³

The framework of the gantry (noted as ‘shipping gallery’ in Figure 45) was springing up by 1919, taking the bulk wheat from the silo to the water’s edge, and along its conveyors to the ships via large discharging towers.¹⁷³ The wharf was still under construction, while the existing coal wharf at the western end was being raised four feet, as well as widened and strengthened, “to adapt for its new use,” being joined with the new wharf to form a wharf of 3440 feet, running into Johnston’s Bay.¹⁷⁴ The new wharf provided berths for five of the largest wheat carriers, and further wharfage accommodation was to be provided later, as required. The silos, railway, and wharves were expected to be in full working order in 1920.¹⁷⁵

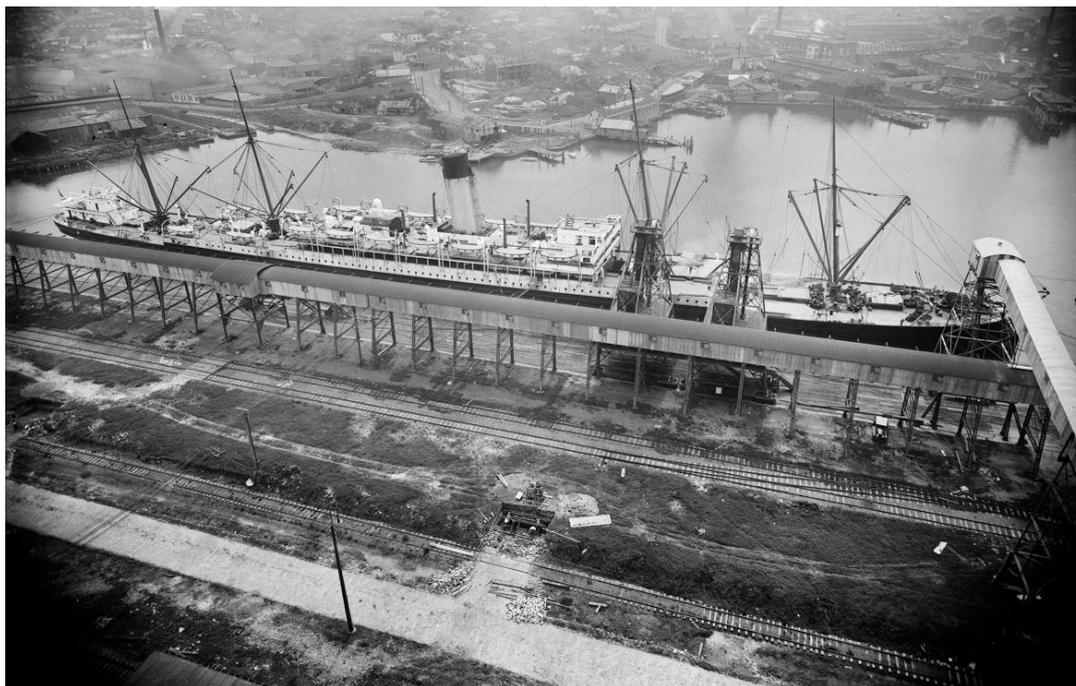
Figure 50: View of the new 'shipping galleries'/gantries as seen from the silos, c1922. Source: SLNSW, FL 412655¹⁸⁶

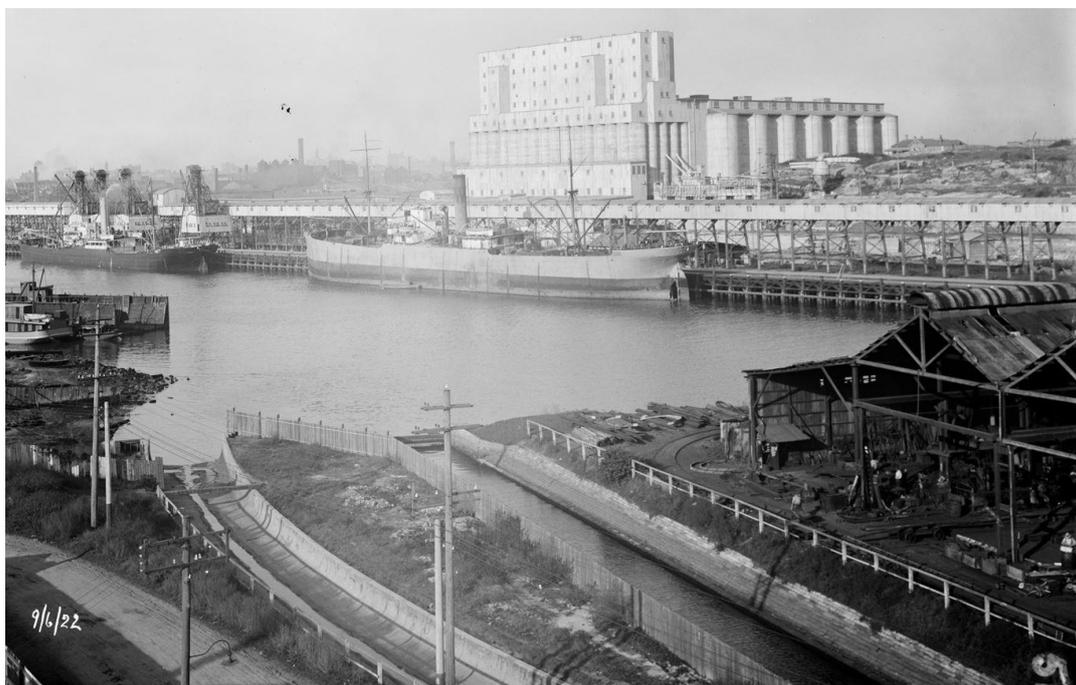
Figure 51: Photograph dated 9 June 1922, showing the new silos and wharfrage from the northwest. This photo also shows the White Bay Steel works (RHS) and the circulation input channel to the White Bay Power Station Source: SLNSW, FL 412667¹⁸⁷

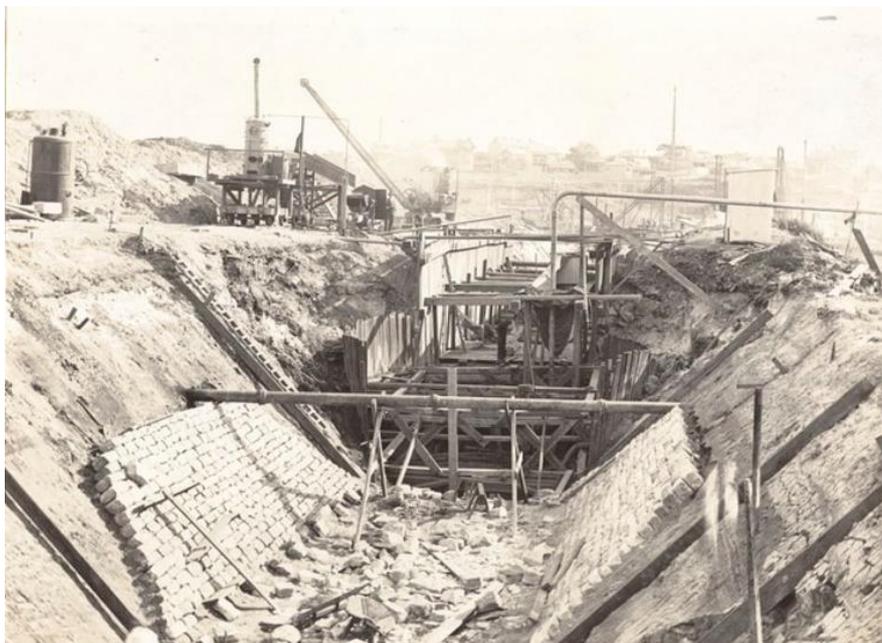
Figure 61: 'White Bay Power Station – Commencement of conduit for circulatory water', 26 September 1912. Source: NSW State Records & Archives, FL 1783554²¹¹

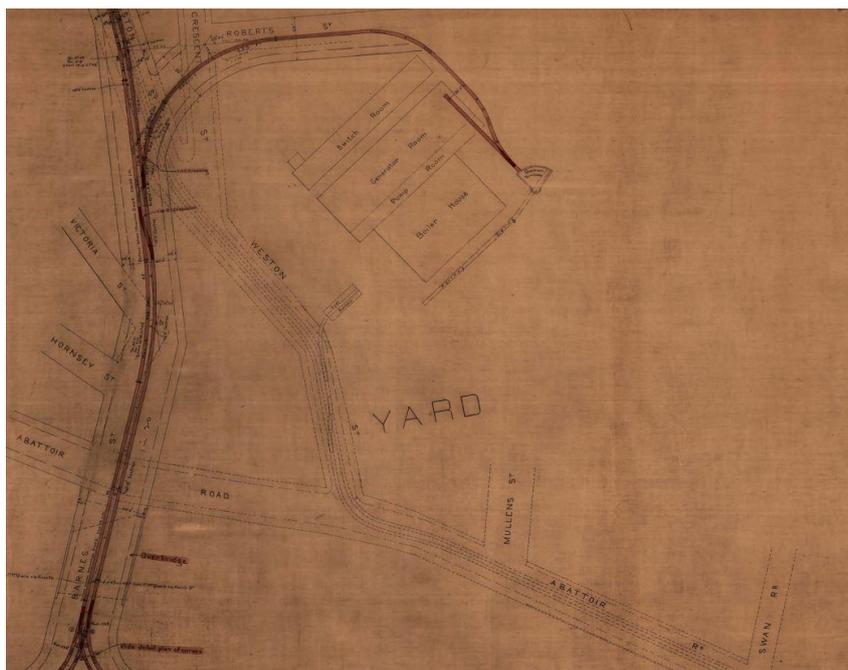
Figure 64: Detail from “N.S.W. G.T. – Balmain Line – General Plan of Proposed Deviation – re Glebe Island Railway”, showing the location of the quadrant turntable and arrangement of buildings constructed as part of the first stage of the White Bay Power House. The alignment of roads that were subsequently resumed is also shown. Source: Transport for NSW Plan Room, 0049124

A tender for the construction and supply of a quadrant turntable at White Bay was sought in April 1915.²¹³ The contract was awarded to Hy. Vale & Sons as the lowest tenderer.²¹⁴ This turntable was located at the northern end of the coal tracks, adjacent to the Boiler House and is shown on a plan dated 5 March 1915 (Figure 64).²¹⁵ The plan also shows the original alignment of those portions of Weston Street and Abattoir Road that were located on the power house site and were resumed and demolished, including old tram tracks. The site was bounded by the newly aligned Barnes Street in the west and Commercial Road in the south.

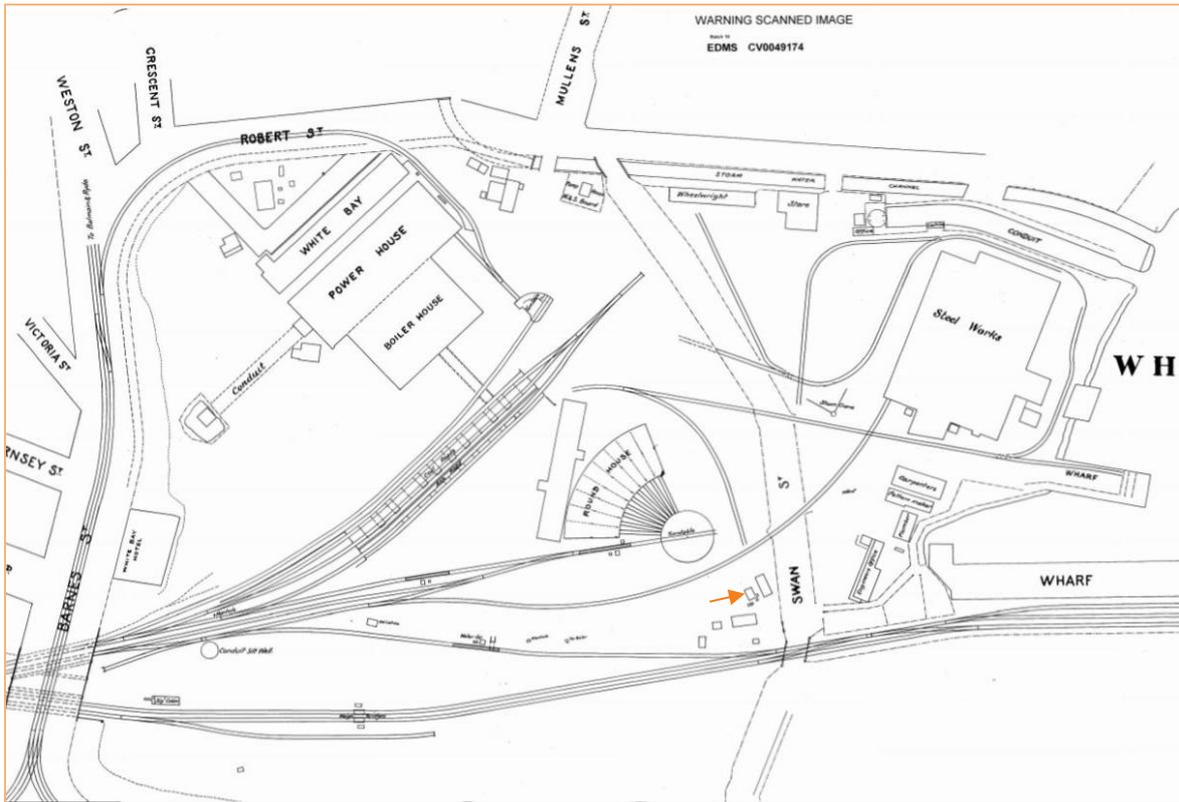
Figure 66: Detail from 'N.S.W.R. - White Bay – Site Plan of Round House', dated June 1919. It shows the location of buildings, water conduit, round house, turntables, wells, vents, boilers, and tracks. Source: Transport for NSW Plan Room, 0049174

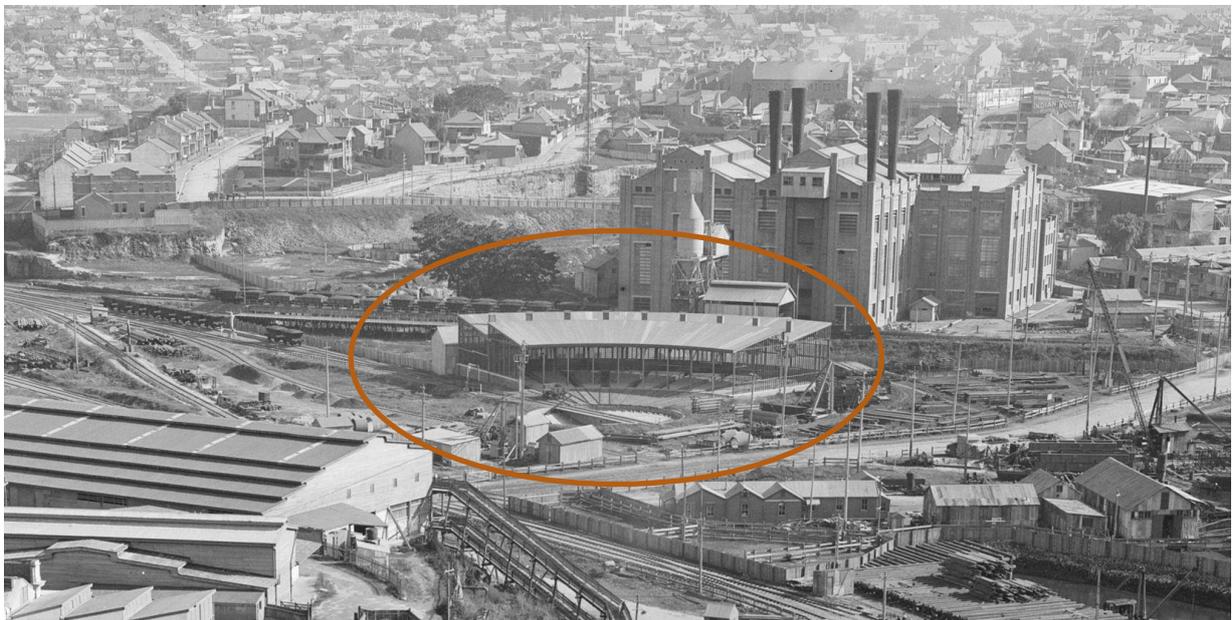
Figure 67: The White Bay Power House site in c1919, with the area of the roundhouse and turntable circled. The roundhouse is under construction, with the side walls missing. Behind it, part of the store for the Electrical Branch is visible. Source: SLNSW, FL412660²²³

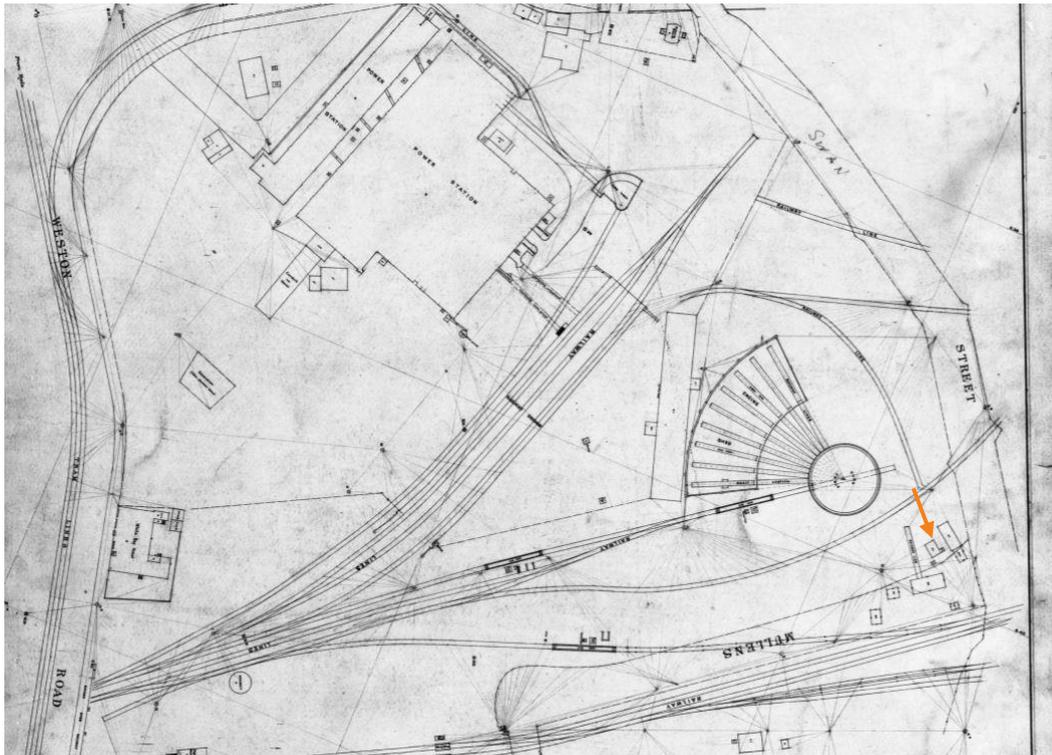
Figure 68: Detail from MBWS & S plan dated April 1920, showing buildings and tracks at the White Bay Power House site as existing by that time. One of the smaller sheds near Swan Street was a transformer house (noted by the arrow). Several buildings nearby were demolished shortly later, when the Swan Street deviation was constructed (noted as Mullens Street on the plan). Source: Sydney Water Archives, DTS 11, MBWS & S, Balmain Sheet 51

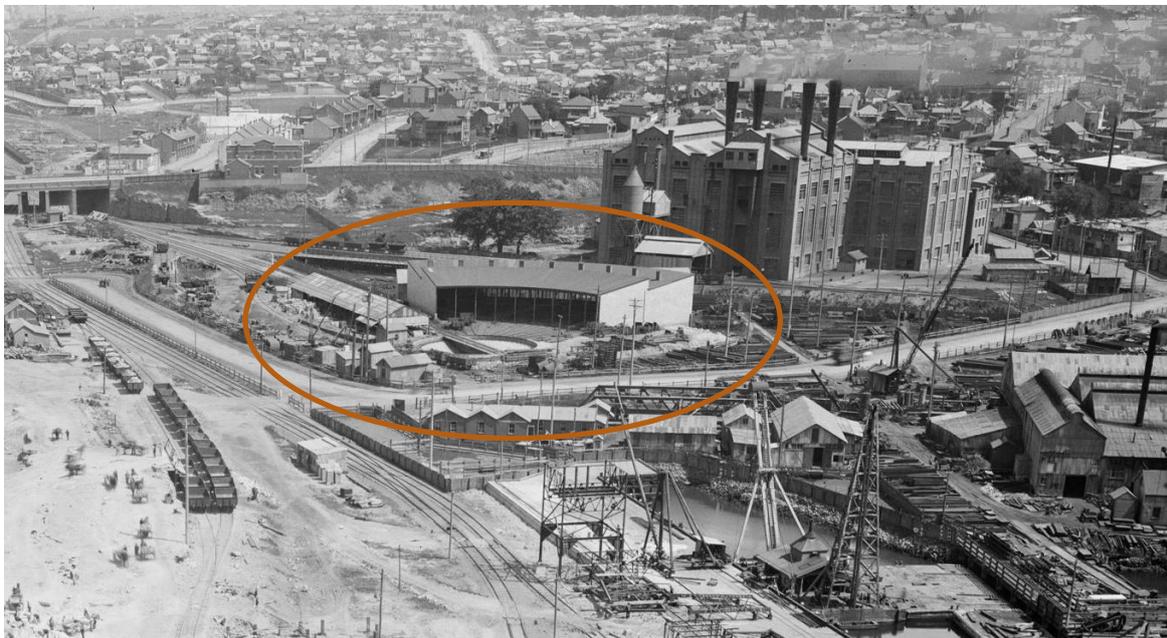
Figure 69: The White Bay Power House site, 28 September 1920, with the area of the turntable circled. The roundhouse appears completed and the Concrete Works have been added to its south (left). Note the newly formed Swan Street deviation on the left, involving demolition of some earlier sheds near the Swan Street crossing. Source: SLNSW, FL 412658²²⁴

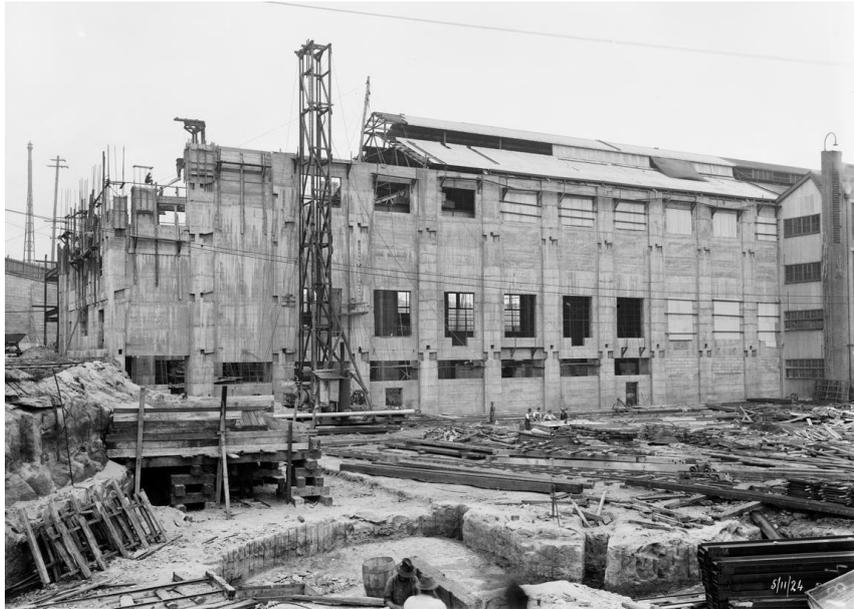
Figure 72: White Bay Power House showing extension of the Turbine Hall under construction, 1924. Source: SLNSW, FL382932²³³

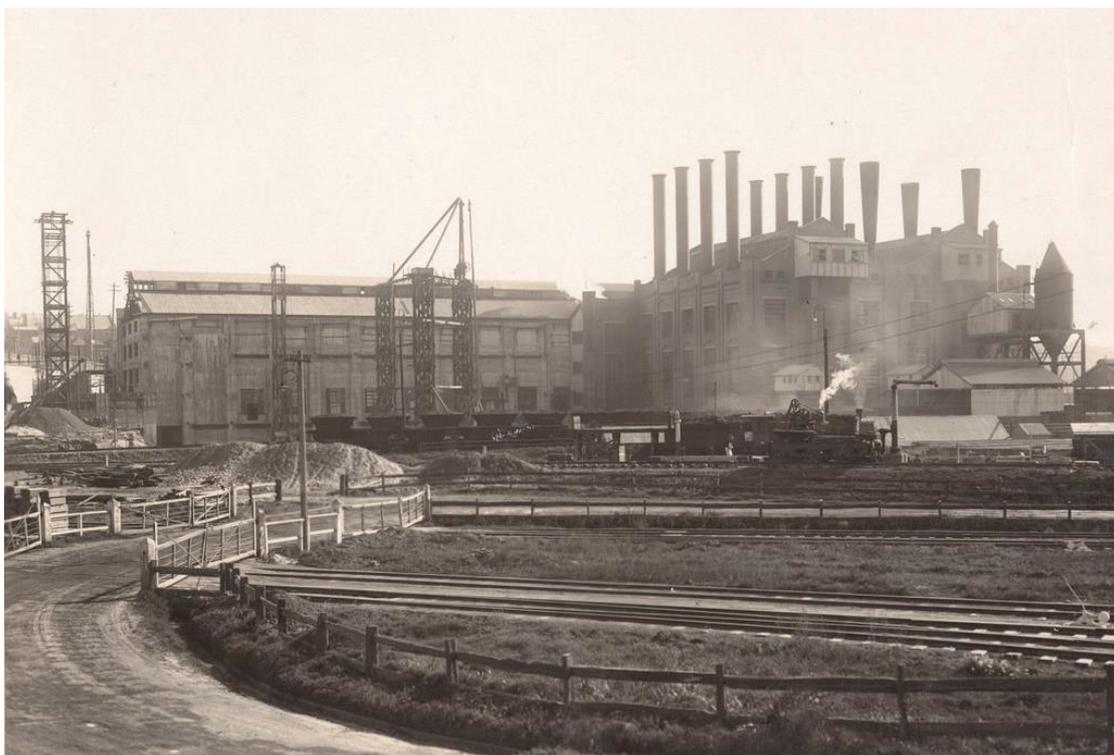
Figure 73: White Bay Power House being extended, circa mid-1920s. View across yard, with the crossing from the Swan Street deviation visible on the left. Note the water crane used for refilling locomotive tanks while they were shunting. Boiler House No. 2 is not yet standing. Source: NSW State Archives & Records, FL1783292²³⁴

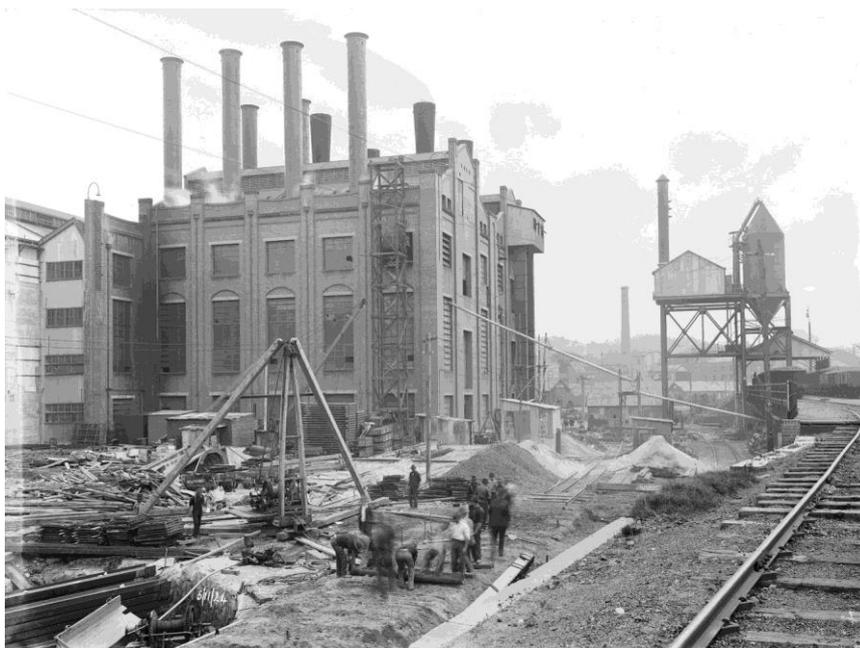
Figure 74: White Bay Power House, 1924, showing works underway. Source: SLNSW, FL382928²³⁵

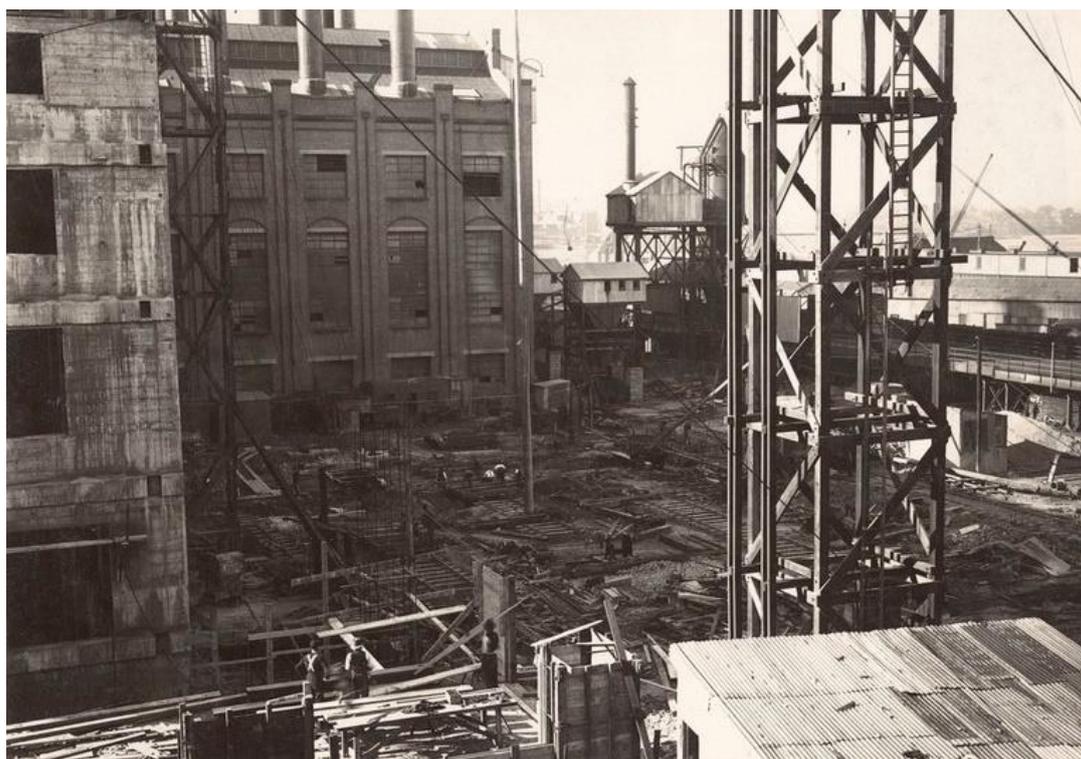
Figure 75: White Bay Power House Extensions, 23 April 1925. Roundhouse and store visible at the far right, behind the elevated coal and ash tracks. Source: NSW State Archives & Records, FL1783374²³⁶

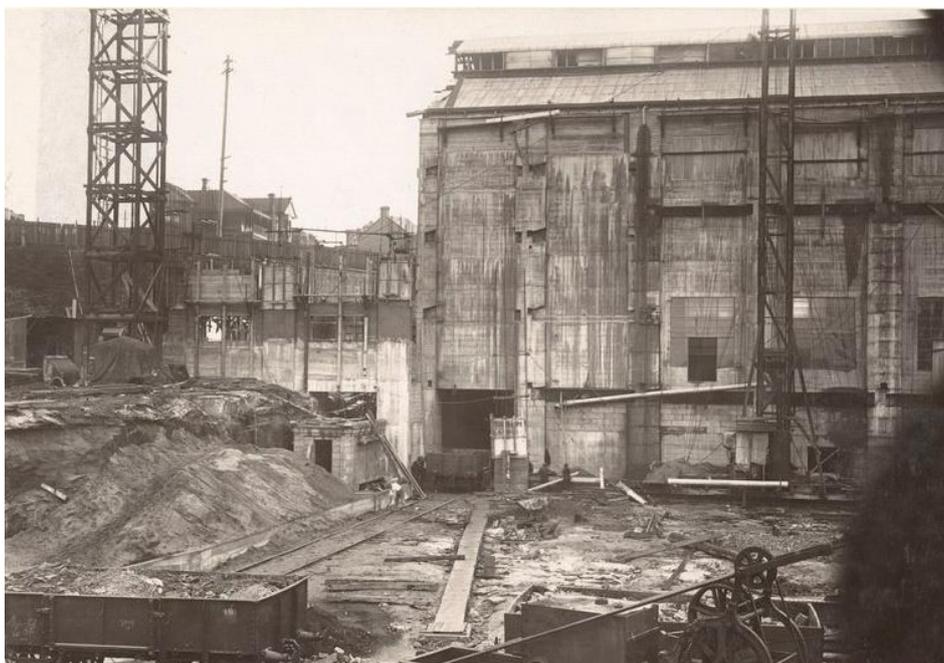
Figure 76: White Bay Power House, 17 June 1925. Construction of the new amenities building has begun. Source: NSW State Archives & Records, FL1784052²³⁷
