Metro West – The Bays

FINAL Revised Archaeological
Research Design and Excavation
Methodology

Report to AFJV / Sydney Metro

November 2021

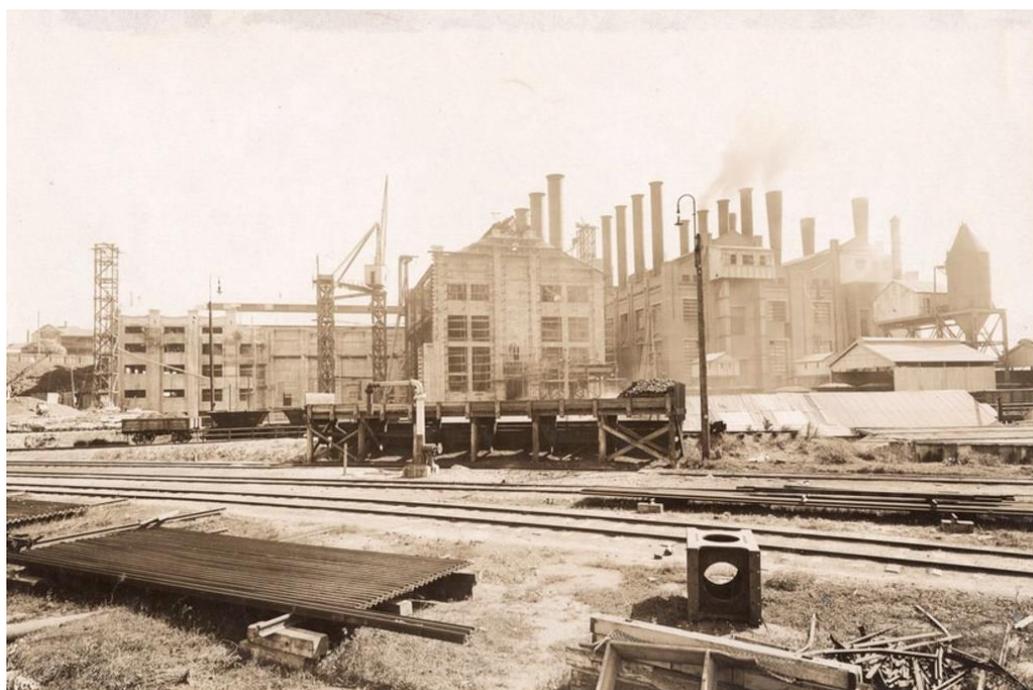
Figure 77: Extension of White Bay Power Station, 1920s. View across tracks and coal handling plant. One portion of Boiler House No. 2 has been constructed. Source: NSW State Archives & Records, FL1783671²³⁸

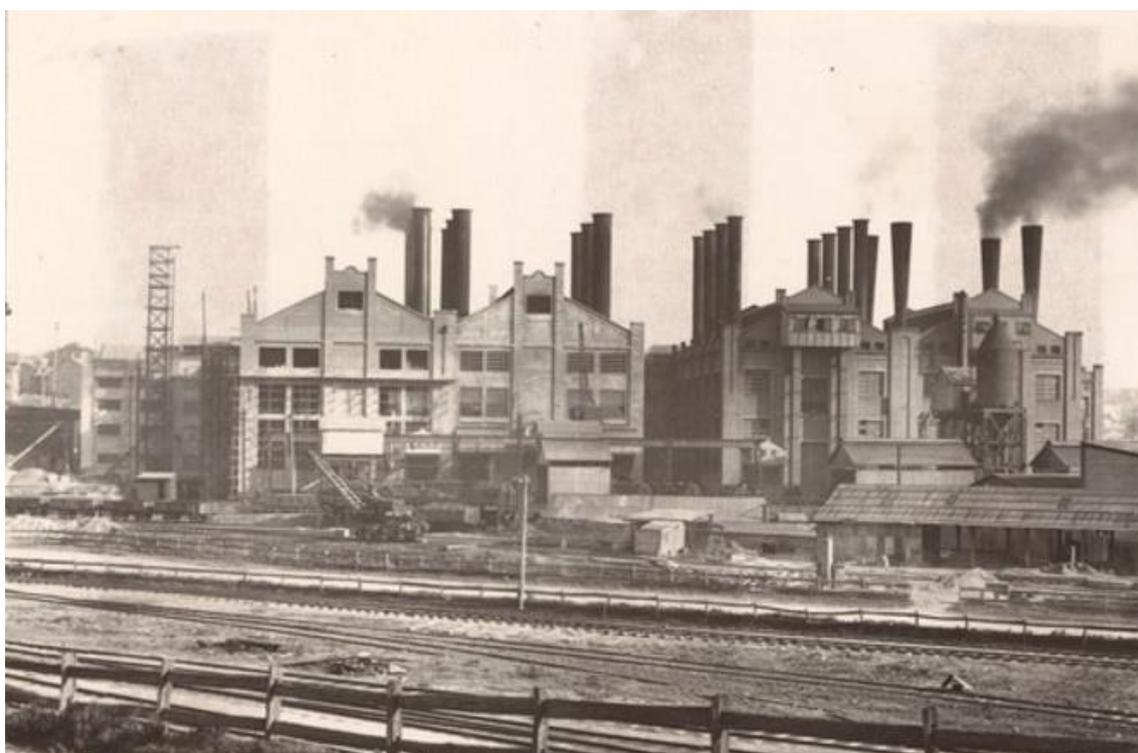
Figure 79: White Bay Power House Extensions, 16 August 1927. New coal and ash handling plant is under construction in front of Boiler House No. 2 (on left). Source: NSW State Archives & Records, FL1784010²⁴⁰

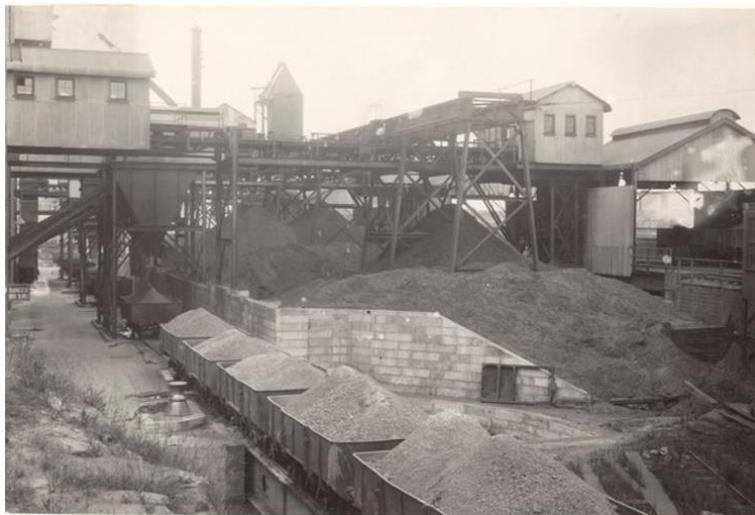
Figure 82: White Bay Power House, 12 February 1930, showing the coal stack and coal and ash handling plant in front of Boiler House No. 1 and 2. Source: NSW State Archives & Records, FL1783902²⁴³

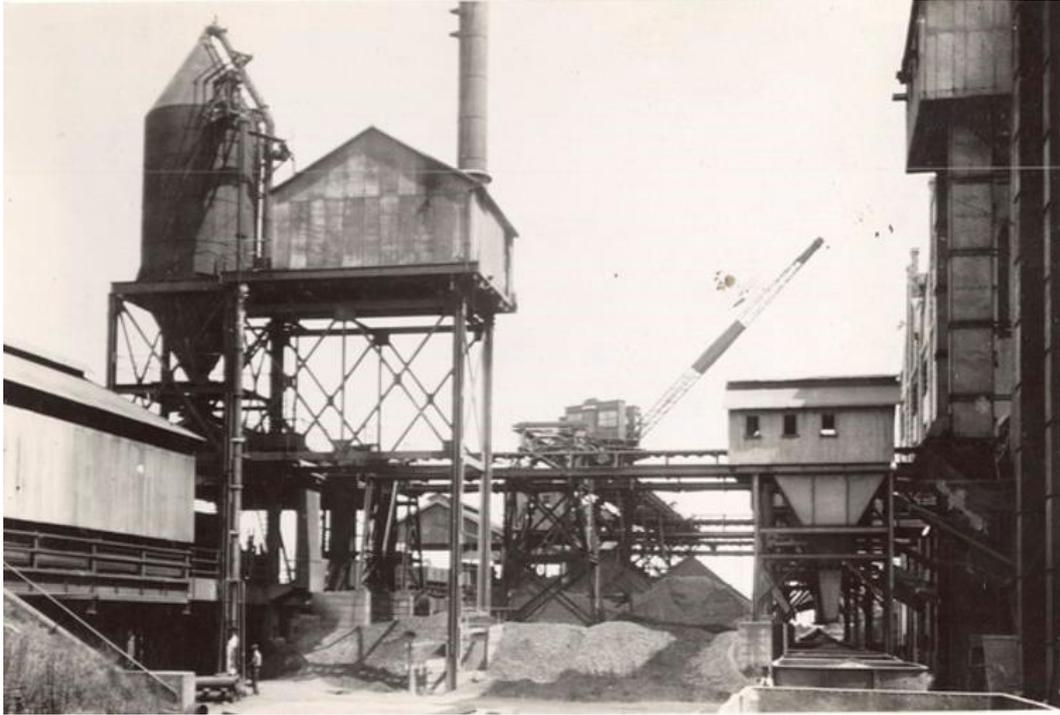
Figure 83: White Bay Power House, 12 February 1930, showing the coal stack and coal and ash handling plant in front of Boiler House No. 1 and 2. Source: NSW State Archives & Records, FL1783902²⁴⁴

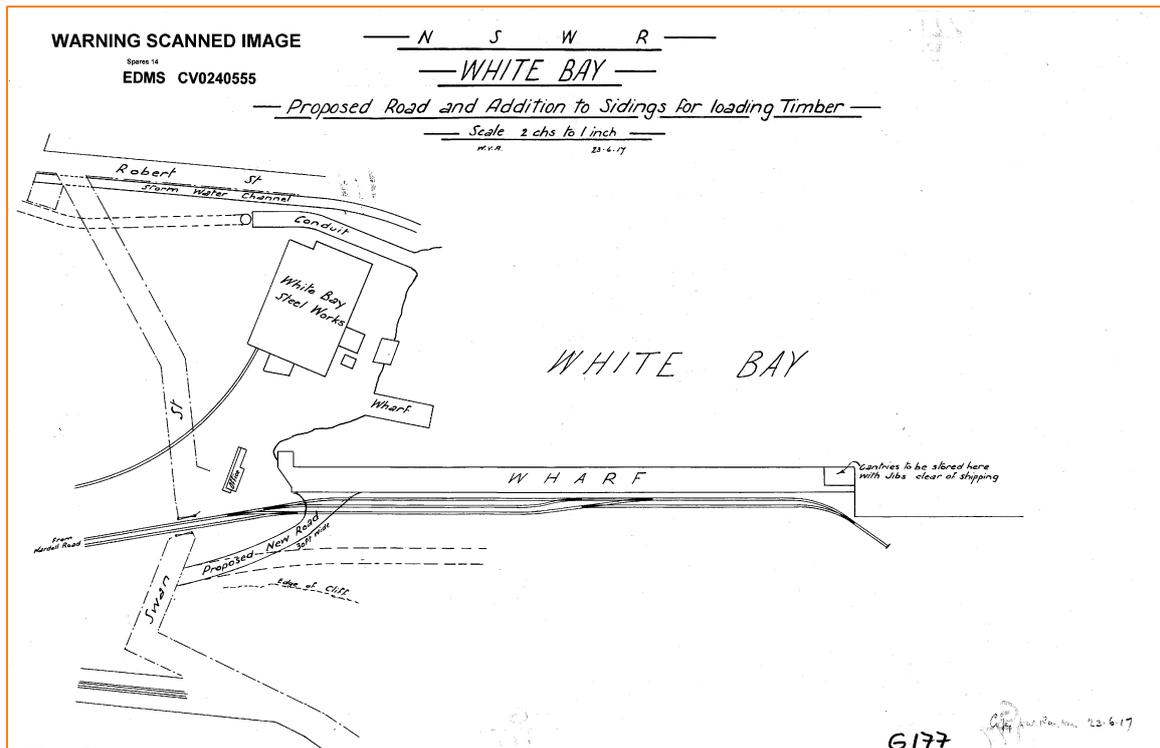
Figure 88: ‘NSWR – White Bay – Proposed Road and Addition to Sidings for loading Timber’, dated 23 June 1917, showing the White Bay Steel Works at top left, with an ‘Office’ noted at the western end of the Glebe Island Wharf. Source: Transport for NSW Plan Room, 0240555

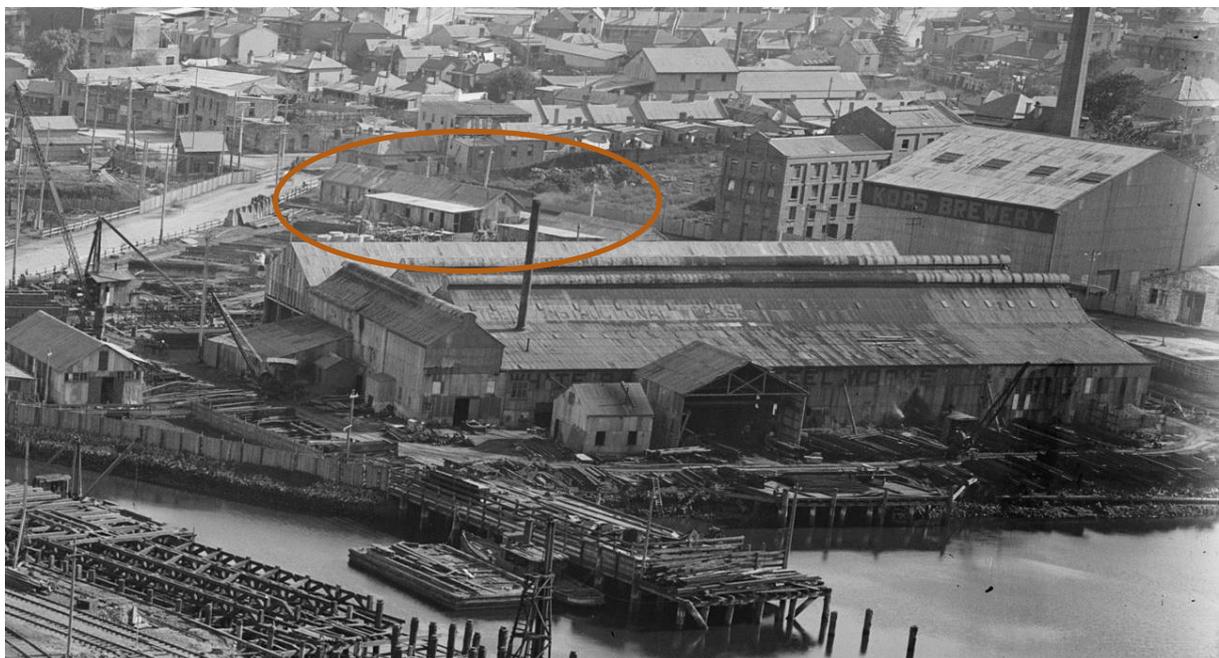
Figure 89: The northern portion of the Railway Department Steel Works in c1919, after having been extended. The ‘White Bay Steel Works’ signage is visible alongside the large shed at the front. The buildings circled orange, located on Swan Street, were the Wheelwrights shop and a store. The small building on the left of the image was the carpenters shop. Source: SLNSW, FL412660²⁶³

Photographs, held by the State Library and largely taken by Arthur Ernest Foster, photographer, in c1919 and 1920, show the construction works underway (Figure 89, Figure 90 and Figure 91). They suggest that the old Government Wharf had been shortened by that time and the old Cattle Wharf removed, to accommodate access for ships to the new wharves on Glebe Island. The Museum of Applied Arts & Sciences also holds a “photographic album that provides an excellent record of the period of construction (1918-1921) of the original Glebe Island Grain silos and the grain handling machinery that was installed when the facility became operational in 1921. The black and white images record the progress of the construction of the three main building structures, namely, the storage bins, working house, track sheds, plus the external conveyors, grain machinery and associated infrastructure”.¹⁷⁶ These photographs have not yet been digitised.

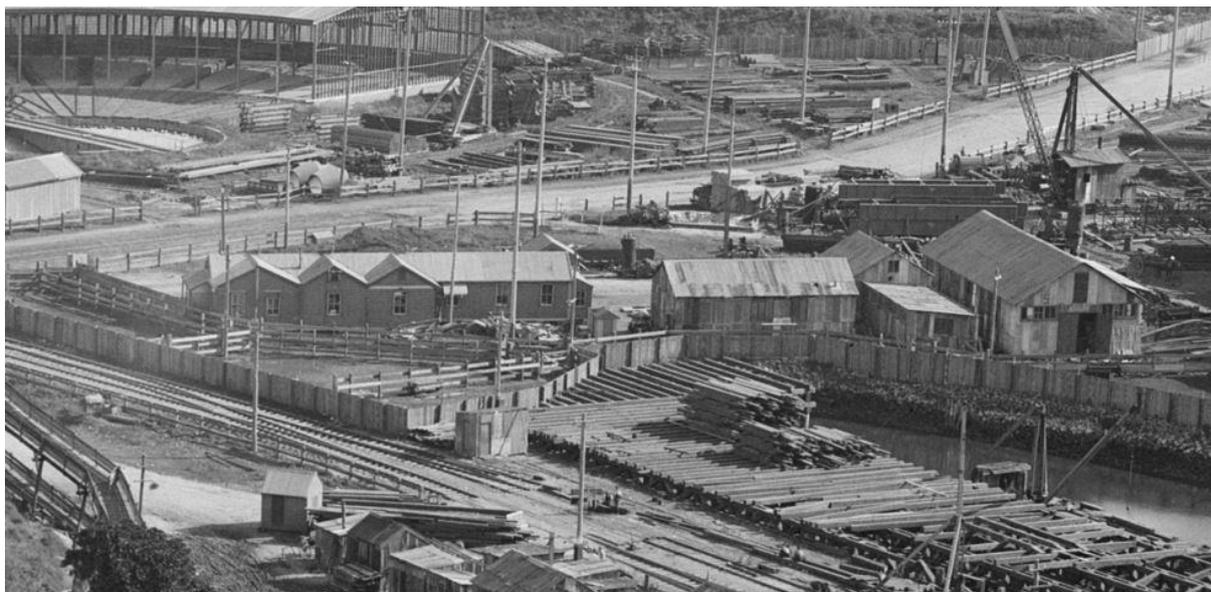
Figure 90: The southern portion of the Railway Department Steel Works, c1919. Some of these buildings may have been constructed during the 1910s by Millar's Timber & Trading Co., and were reused by the steel works. The building on the left was later noted as the Engineer's Building. Source: SLNSW, FL412660²⁶⁴

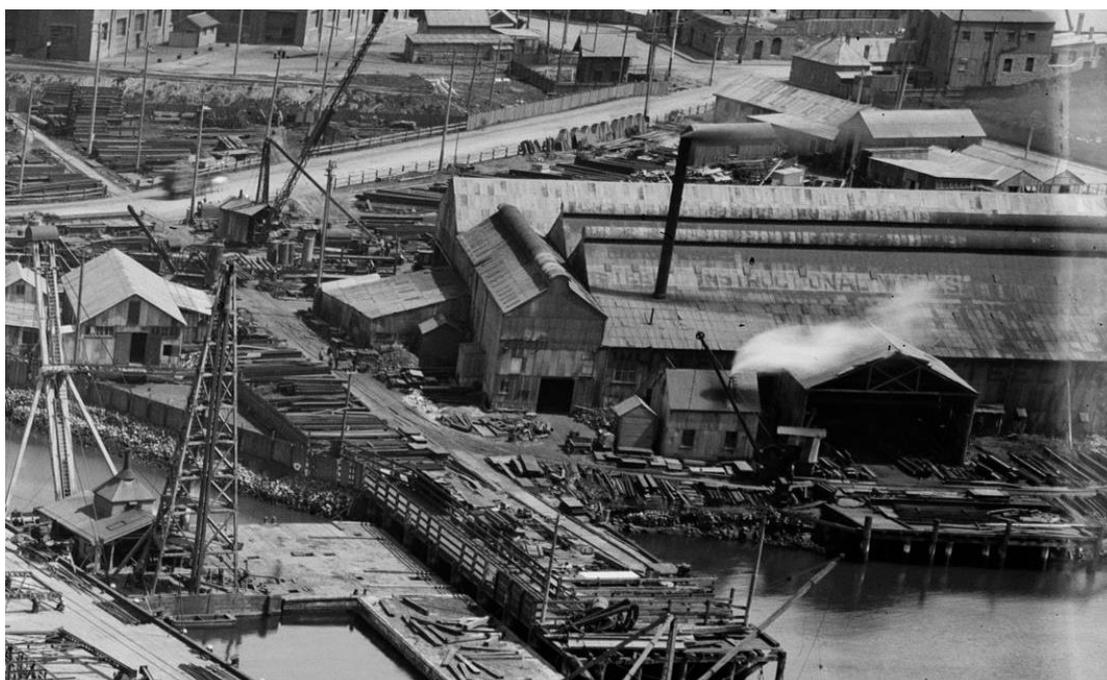
Figure 91: The northern portion of the White Bay Steel Works, 28 September 1920, on right. The Wheelwrights Shop at top right appears to have been extended. Just visible on the left are the carpenter's shop and the smaller pattern maker store. Source: SLNSW, FL 412658²⁶⁵

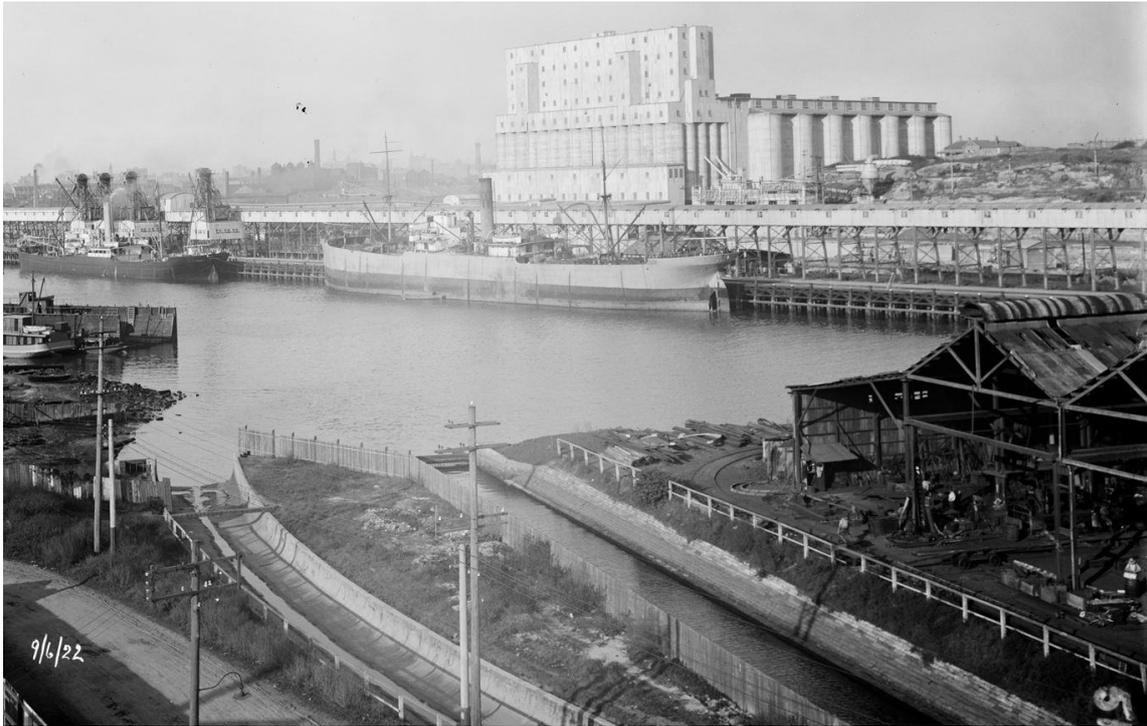
Figure 92: The White Bay Steel Works, on right, 9 June 1922. The stormwater channel is visible on the left and the circulating water conduit, built in c1913, to the right. Source: SLNSW, FL 412667²⁶⁶

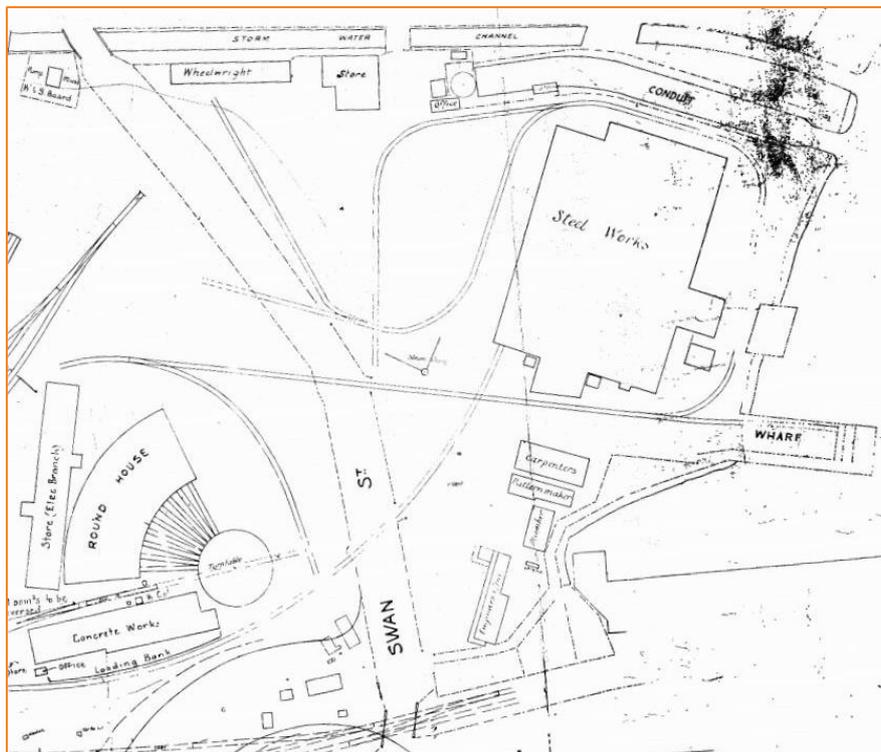
Figure 93: Plan prepared ca 1923 to 1928, showing the White Bay Steel Works as part of the power house site. Swan Street has been deviated by that time, and the water conduit built. Names of buildings are also noted on this plan, as well as sidings and tracks. Source: Transport for NSW Plan Room, 0049125

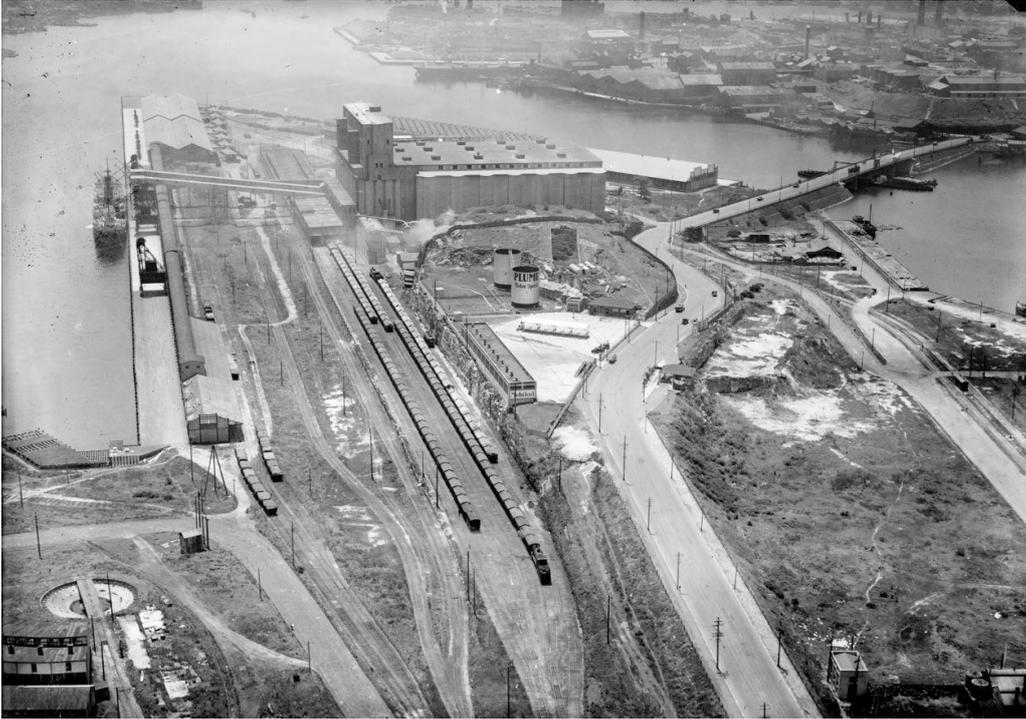
Figure 95: Aerial photograph, 1930s, by Milton Kent, showing the Vacuum Oil Company's works at centre along with the Glebe Island Grain terminal and the railway roundhouse.
Source: SLNSW, FL8805530, c079150007²⁶⁹

In April 1926, the Vacuum Oil Company Pty Ltd submitted an application to Balmain Council for construction of a distributing warehouse on the site of the old abattoir and refrigeration works on Glebe Island, at a cost of £500,000.²⁶⁷ The works included petrol storage tanks and warehouse premises. A 1930s photograph shows the new facility after initial construction (Figure 95).

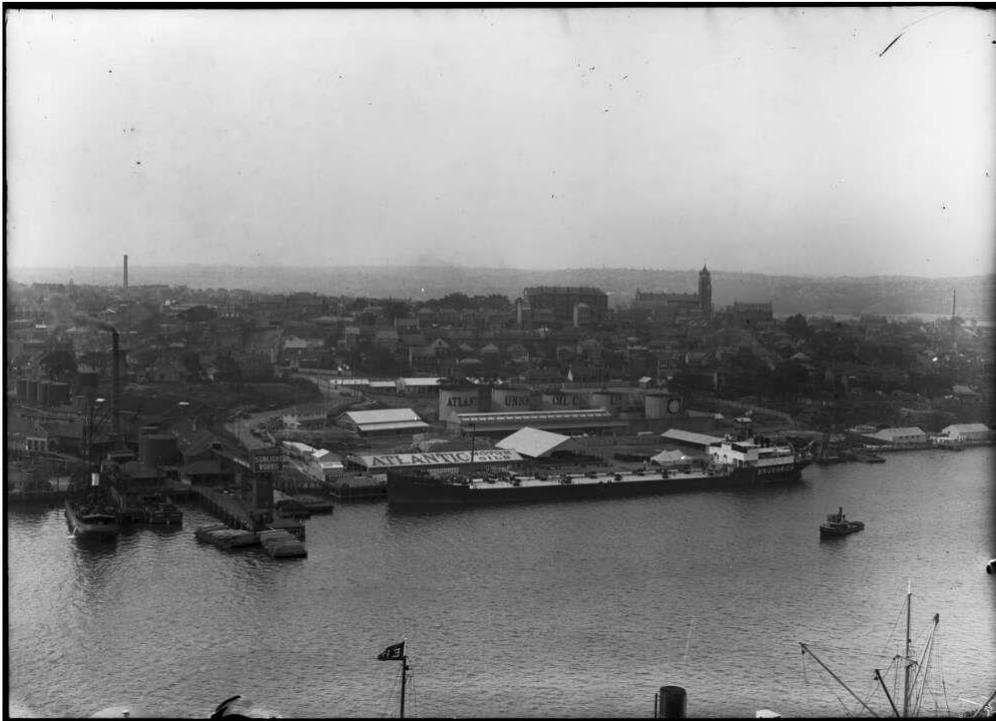
Figure 96: 'Atlantic Motor Oil Depot, Sydney with a ship moored at the dock', by A. G. Foster, taken after May 1928 when the depot was opened on the southern foreshore of the Balmain peninsula. It was connected with the Union Siding at White Bay by underground pipes. Source: National Library of Australia²⁷⁶

peninsula, in May 1928 (Figure 96).²⁷³ The works contained six benzine tanks as well as two Foamite tanks, with the latter constructed as a fire safety measure. Pipelines delivered their products to the 'Union Siding' at White Bay, as described in 1929: "Underground, through piping, motor spirit and kerosene can be pumped from the big main tanks to the Rozelle railway siding (a distance of approximately a mile). And it seems that a 5,000 gallon tank car can stand away at the railway siding at Rozelle and be filled in 70 minutes by pumps at the Balmain Terminal."²⁷⁴

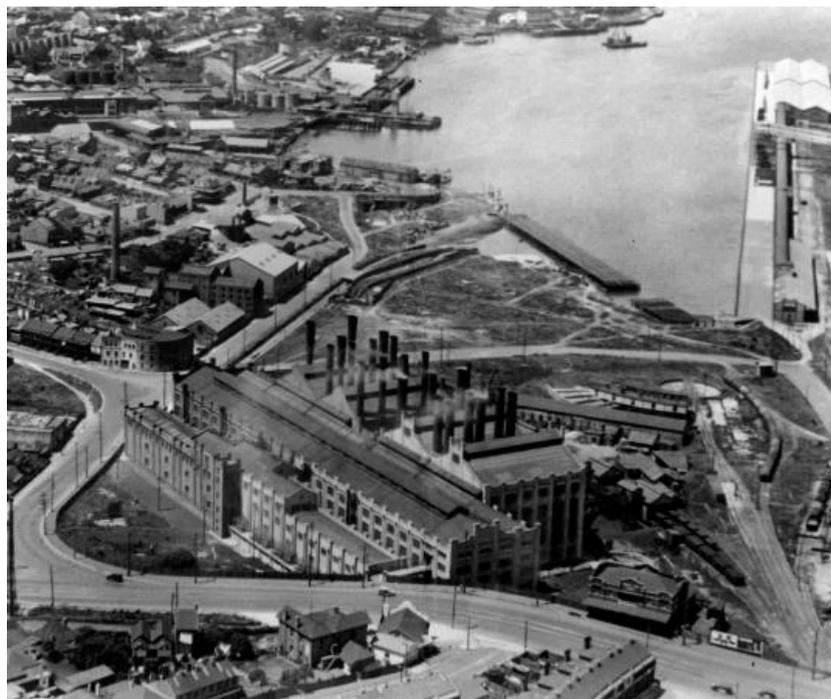
Figure 99: White Bay Power Station site, c1931. This photograph was taken after removal of all the buildings connected with the steel works at the head of the bay. The roundhouse was still standing by that time. Construction of a new long-shore wharf had begun but came to a halt due to financial issues. Source: City of Sydney Archives, SRC352²⁷⁹

(Figure 99).²⁶⁰ The roundhouse and turntable remained standing at that time, with the turntable later said to have been removed to Broadmeadow.²⁶¹

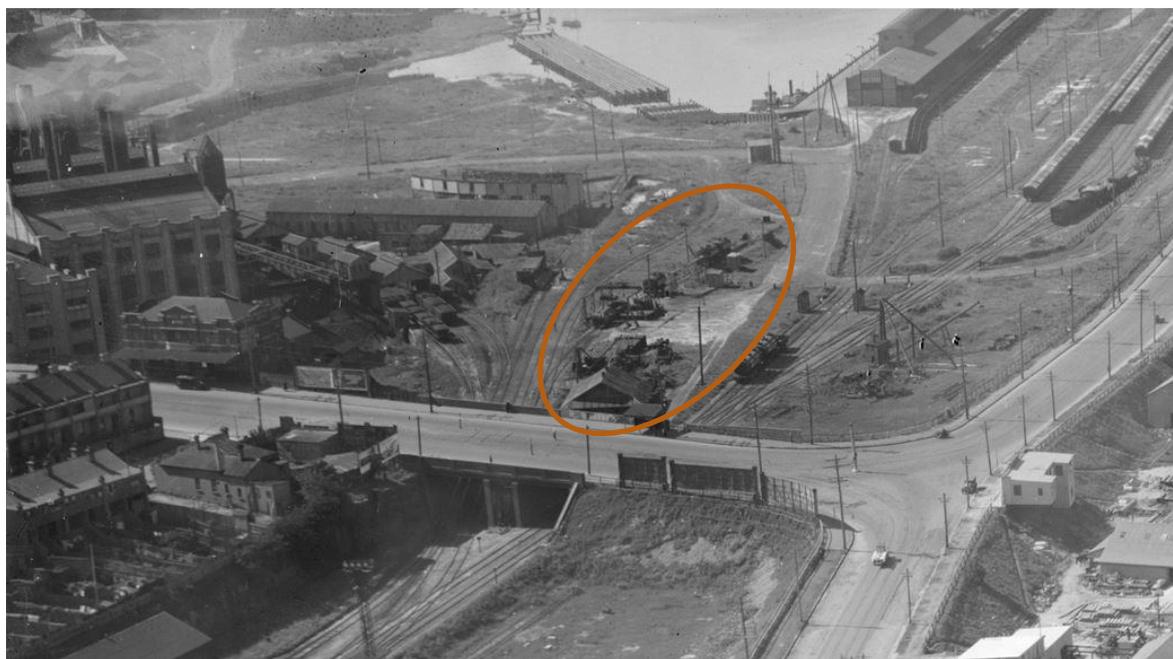
Figure 100: Aerial view of the White Bay Power Station site, c1931, by Milton Kent. The incomplete long-shore wharf is visible at the top, while the new Union Siding and Yardmaster's building are shown at centre, circled. Source: SLNSW, ON 447/Box 157, FL8812345²⁸⁰

Construction of the new coal loading wharf had progressed well up to the end of September, but subsequently stopped due to financial issues caused by the Great Depression. The new, incomplete wharf is visible in Figure 100. In January 1936 it was reported that “erection of new coal loading jetties at White Bay had been recommenced after the depression.”²⁷¹ The new coal loading facility was known as “No. 1 Balmain Wharf” and appears to have been in use by December 1937.²⁷² It is visible in the 1943 aerial (Figure 104), by which time additional land had been reclaimed between the new wharf and the area of the stormwater and circulation channels as well as in the area of the junction of White Bay and Glebe Island.

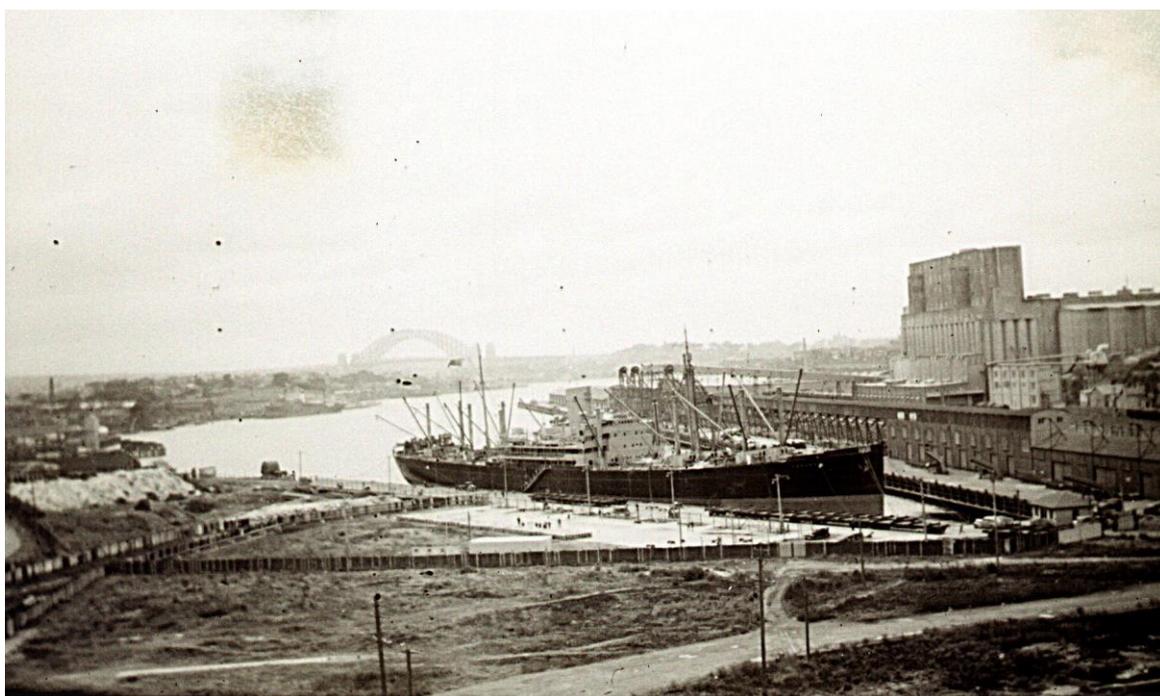
Figure 103: 'Cargo ship at No. 1 White Bay. GA0588a', dated 1950 but likely showing the site in the early 1940s, with a concrete platform poured in front of the wharf. Source: City of Sydney Archives, A-00077504³⁰⁰

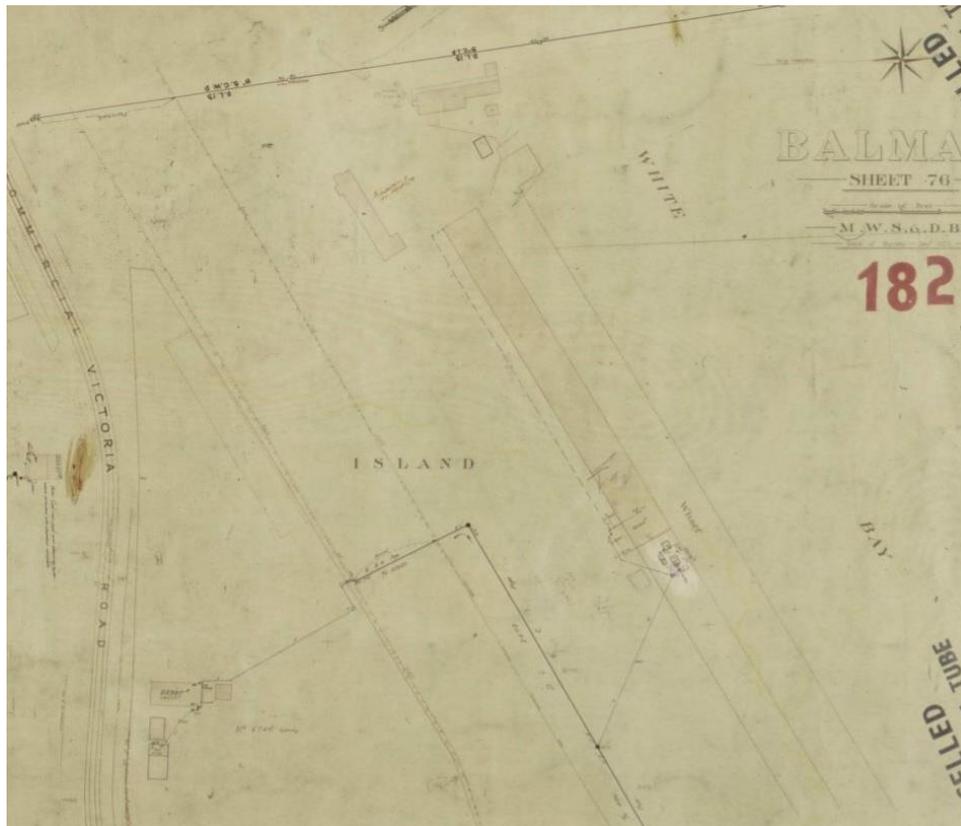
Figure 107: Survey dated September 1927 and updated to 1953, showing the R.A.A.F. mess room adjacent to Shed No. 9. Source: Sydney Water Archives, BLKWTL 182, MWS & DB Sheet 76

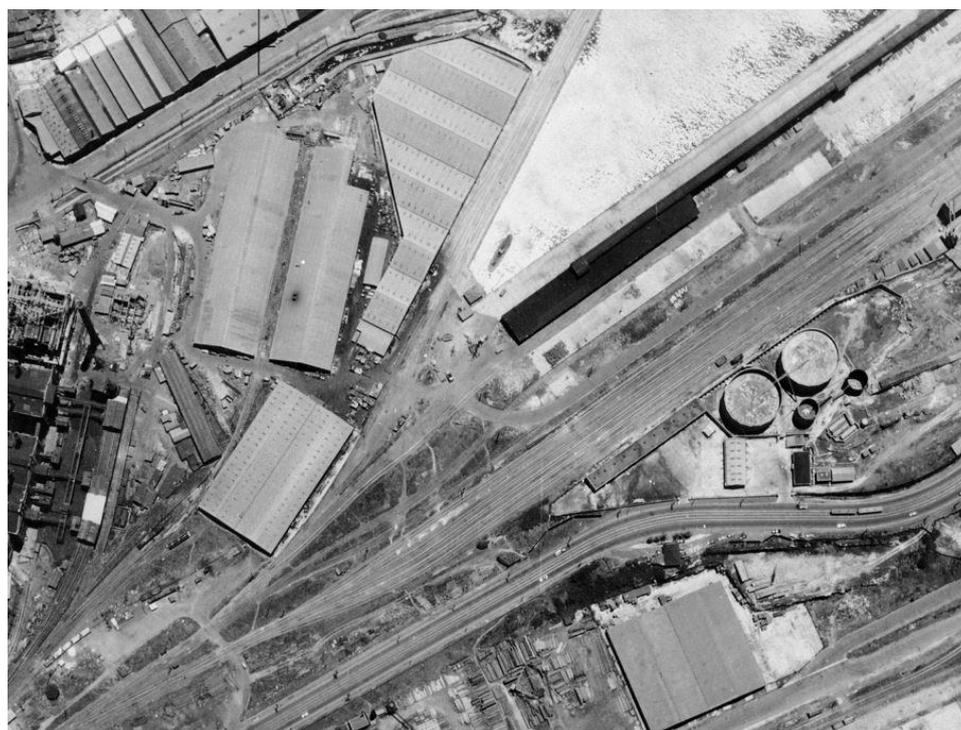
Figure 109: 1948 aerial photograph showing further buildings constructed during occupation by the US and Australian armed forces, including a large building located alongside No. 1 Balmain Wharf. Source: City of Sydney Historical Atlas of Sydney

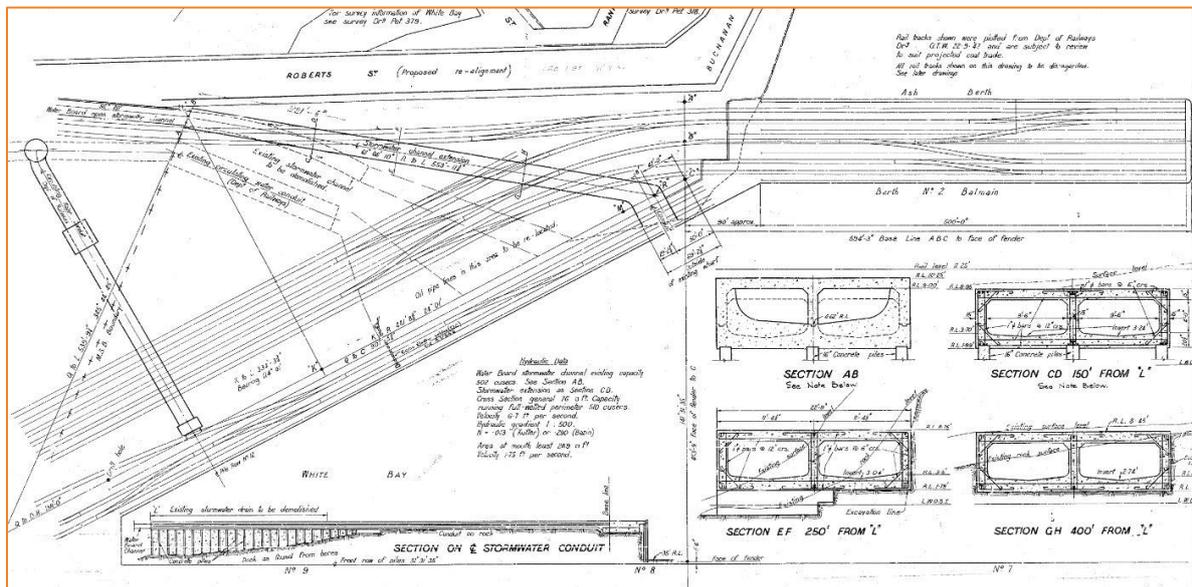
Figure 116: 'White Bay, Berths Nos 1 and 2 Balmain – Proposed Extensions of Circulating and Stormwater Channels', dated 9 November 1948 and updated to 21 September 1950. It shows the new circulating water conduit at left, and the new extension for the stormwater channel at top. Source: Transport for NSW Plan Room, A1/517

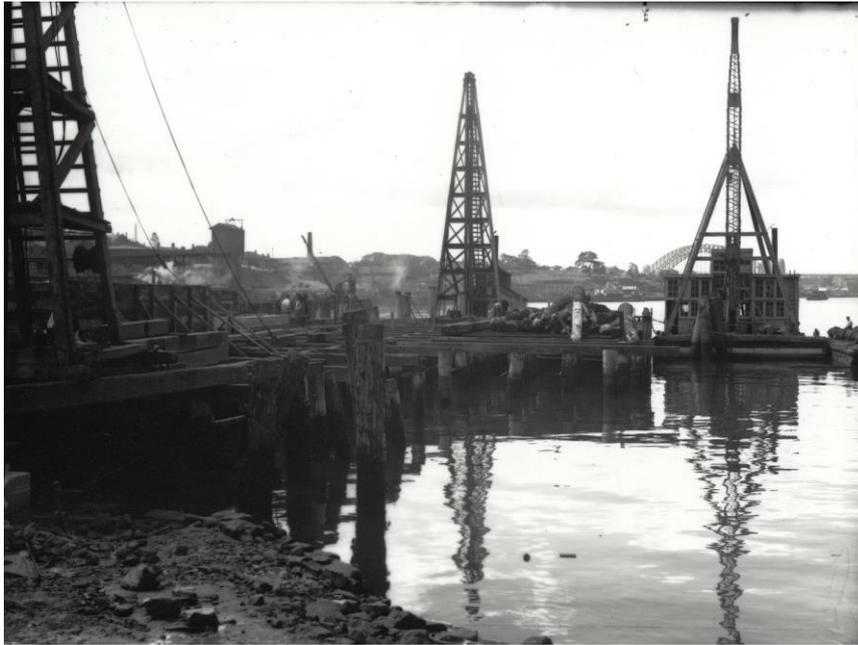
Figure 117: ‘Piles in the progress driving,’ 6 October 1949, for Balmain No. Wharf, as catalogued by the State Library of NSW, d1_07840.³⁰² This image is a better-quality version from the NSW State Archives that is wrongly described as ‘View of Demolition wharf at White Bay No. 1’. Source: NSW State Records & Archives, FL423125³⁰³

While the wheat loading wharfage at Glebe Island was extended in the early 1930s, work “commenced in January, 1930, in connection with providing new coal-loading accommodation, comprising a long-shore wharf and a jetty at White Bay in replacement of the existing railway jetties at Pyrmont.”²⁷⁰ As part of the scheme, the old wharf at White Bay was demolished (Figure 117)

Photographs show that works for the construction of Balmain No. 2 Wharf were underway by the end of 1949 (Figure 117), and at around the same time, demolition of the large stores began (see Figure 118 and Figure 119). By October 1951, sections of the new circulation conduit and stormwater channel were completed, and construction of screen wells were in progress (Figure 121). As part of the works, the existing oil pipelines on the western side of Wharf No. 1 were to be relocated. These were likely connected with the Atlantic Union Co. siding and appear to have run above ground and underground across the site, running over the stormwater channels and circulating water conduit to the north-east.

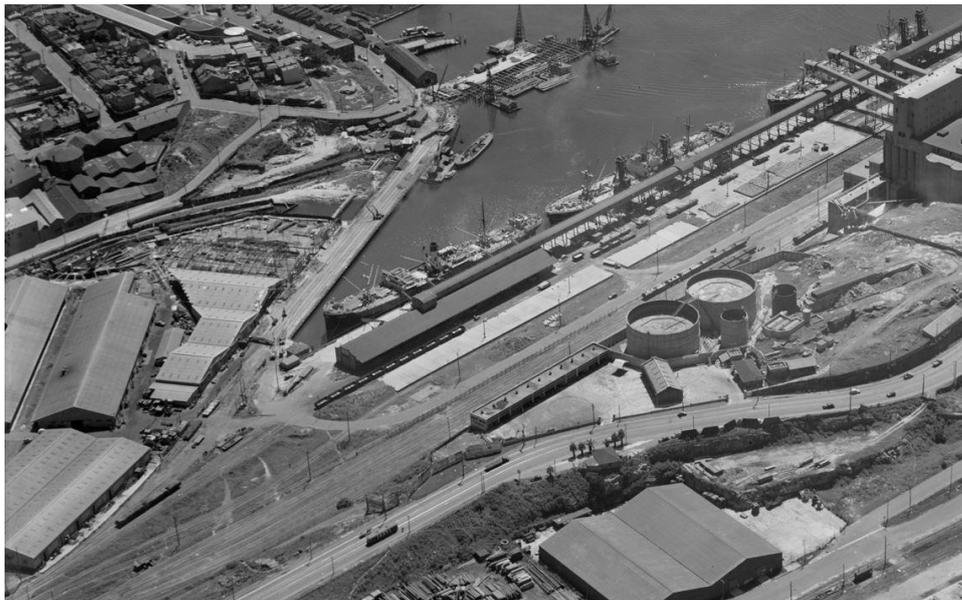
Figure 118: Aerial photograph by Milton Kent, roughly dated 1924-50 but likely taken in 1949 or 1950. It shows Wharf No. 2 under construction at top centre, and the shed adjacent to Wharf No. 1 being demolished. Source: SLNSW, c11450003, FL8811195³⁰⁴

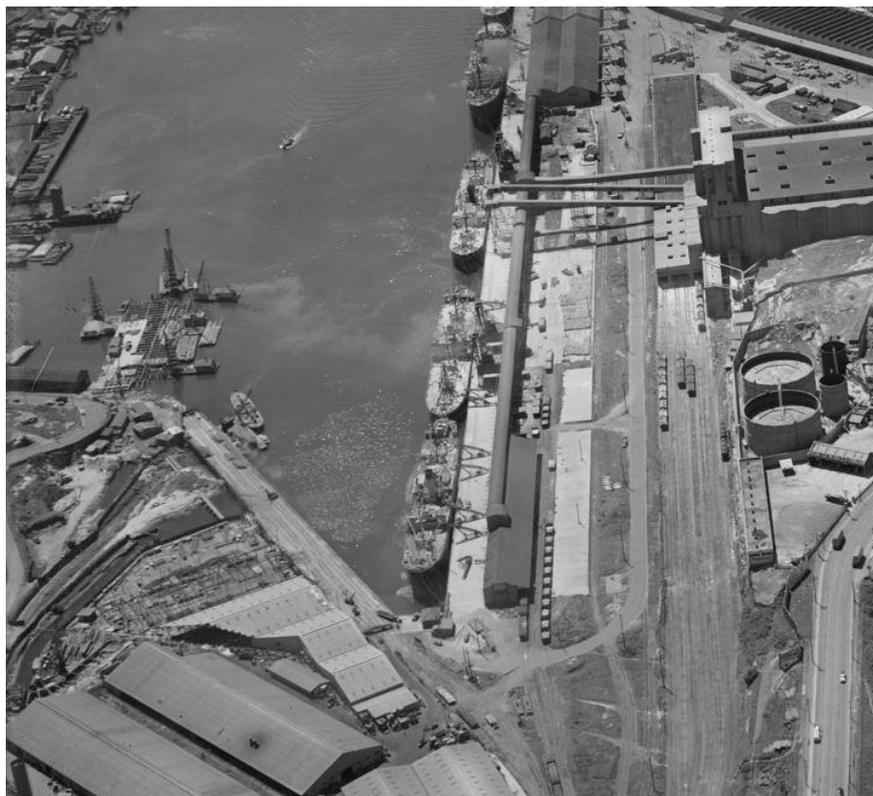
Figure 119: Aerial photograph by Milton Kent, roughly dated 1924-50 but likely taken in 1949 or 1950. Source: SLNSW, c111450001, FL8811193³⁰⁵

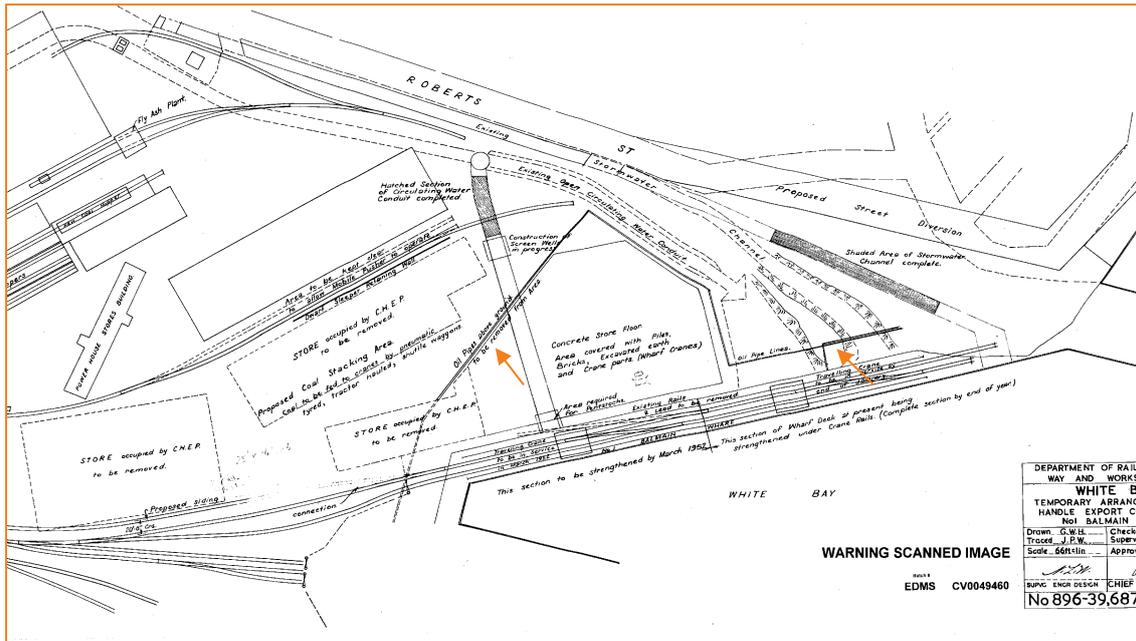
Figure 121: ‘White Bay – Temporary Arrangements to Handle Export Coal from No. 1 Balmain Wharf’, approved 30 October 1951. The diagram shows the proposed removal of stores occupied by CHEP, as well as details for the new wharf. The hatched section of the new circulating water conduit was completed by then. The diagram also shows the oil pipe lines to be removed (noted by the arrow). Source: Transport for NSW Plan Room, 0049460

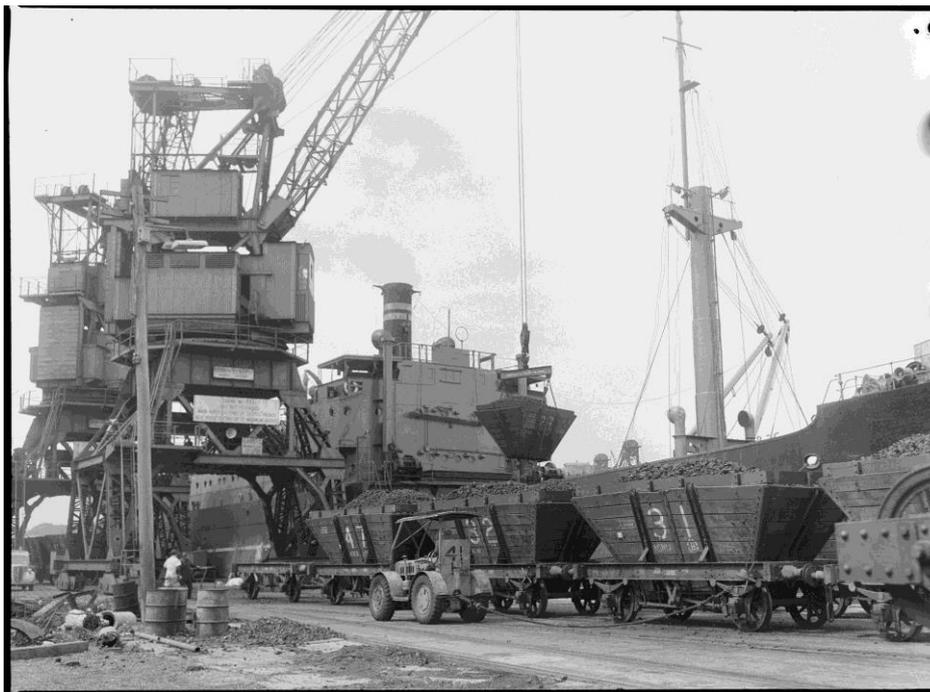
Figure 126: 'Loading Coal from Rail Trucks to Ship at White Bay', 2 December 1958. Source: NSW State Records & Archives, FL2356801³¹⁹

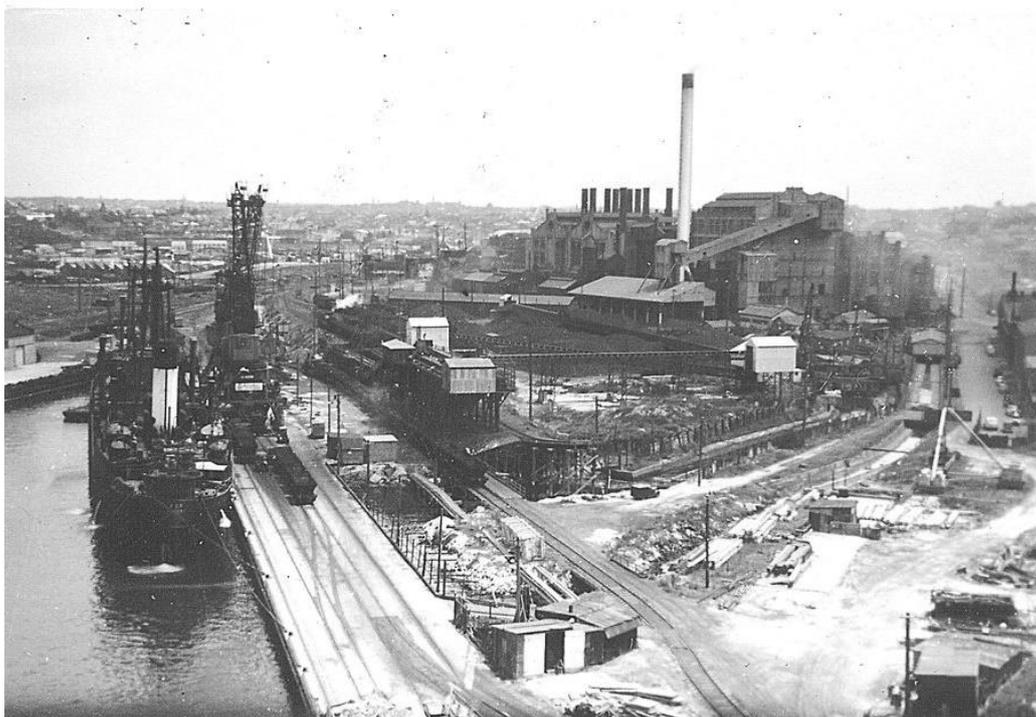
Figure 129: 'Steamship ERA (1921-1955) at White Bay power station', showing the coal stacking area behind the wharf. The stormwater channel has not yet been redirected. Source: City of Sydney Archives, A-00077504³²²

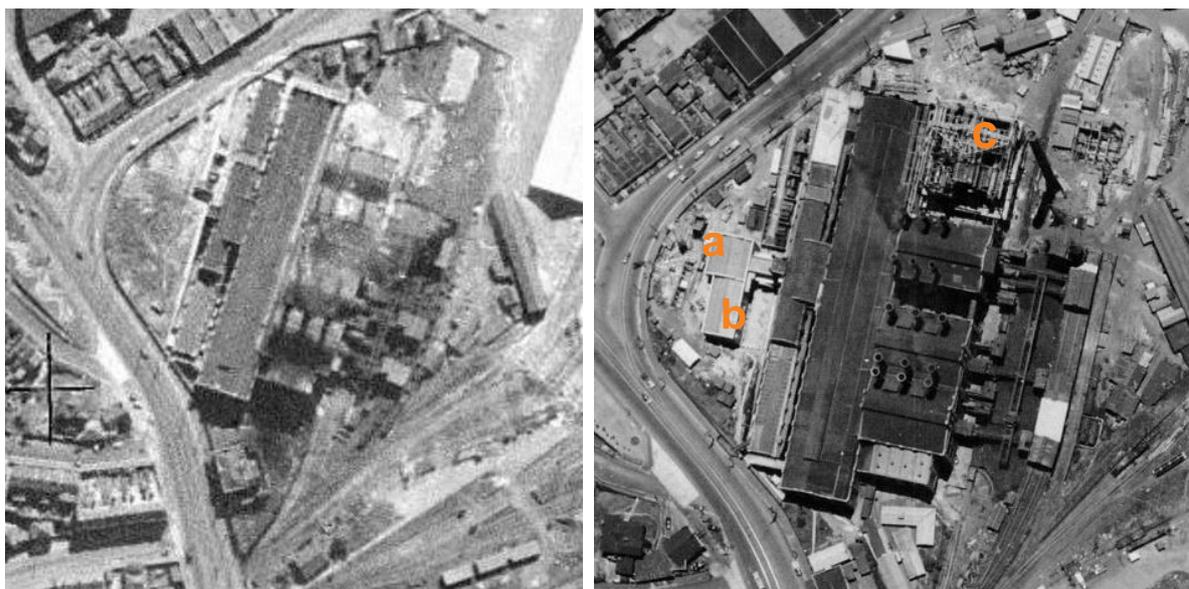
Figure 134: Aerial photographs showing the White Bay Power House site in 1943 (left) and 1948 (right), showing a new control room (a) and 66kV Switch House (b) added in the west and new boiler house (c) under construction by 1948. Source: NSW Spatial Services, Historical Imagery

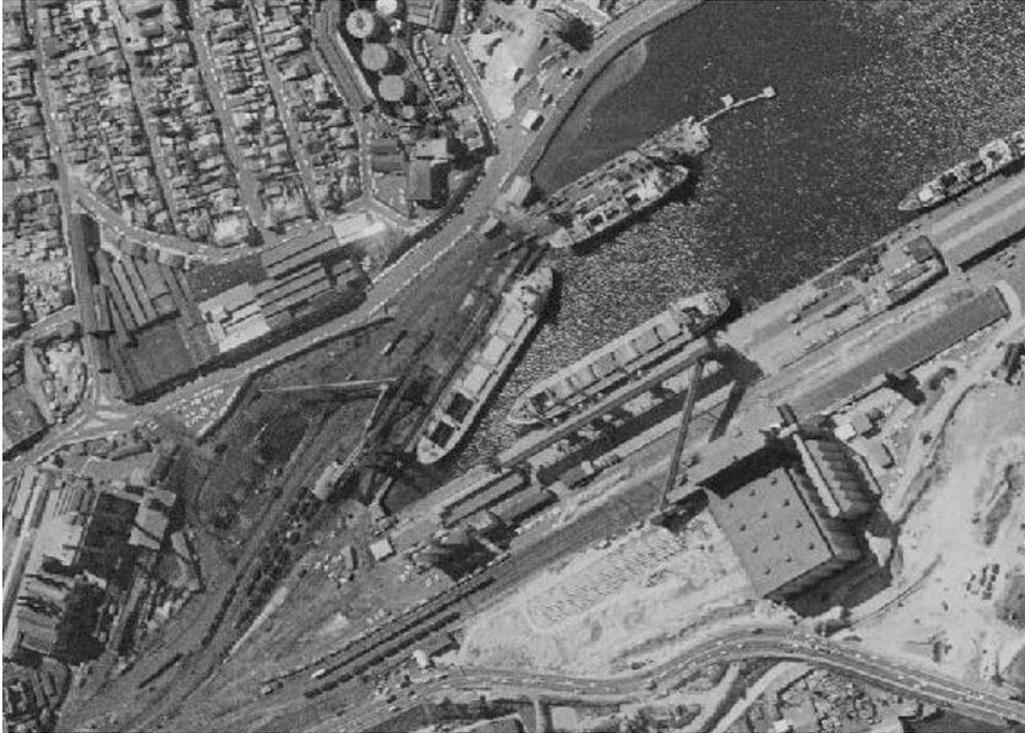
Figure 138: 6 October 1971 – The original shipping galleries and conveyor belts have been removed and new conveyor belt and dry bulk loading facilities constructed, to provide space for a new container handling facility to the north-east of the silos. Source: NSW Spatial Services, Historical Imagery

loading facility that ended at Wharf No. 9. The 1971 aerial photograph included in Figure 138 shows the new facility.

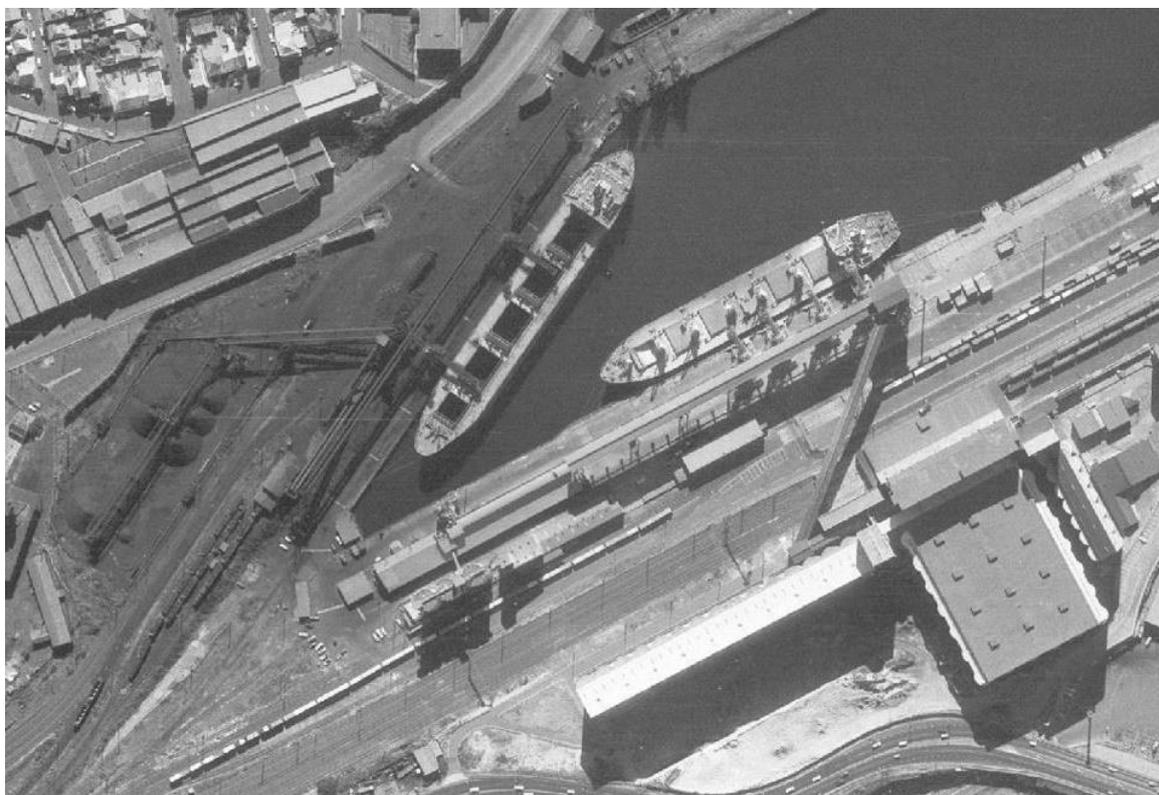
Figure 142: 6 May 1978 – The eastern portion of Shed No. 9 has been demolished. Source: NSW Spatial Services, Historical Imagery
