Metro West – The Bays

FINAL Revised Archaeological
Research Design and Excavation
Methodology

Report to AFJV / Sydney Metro

November 2021

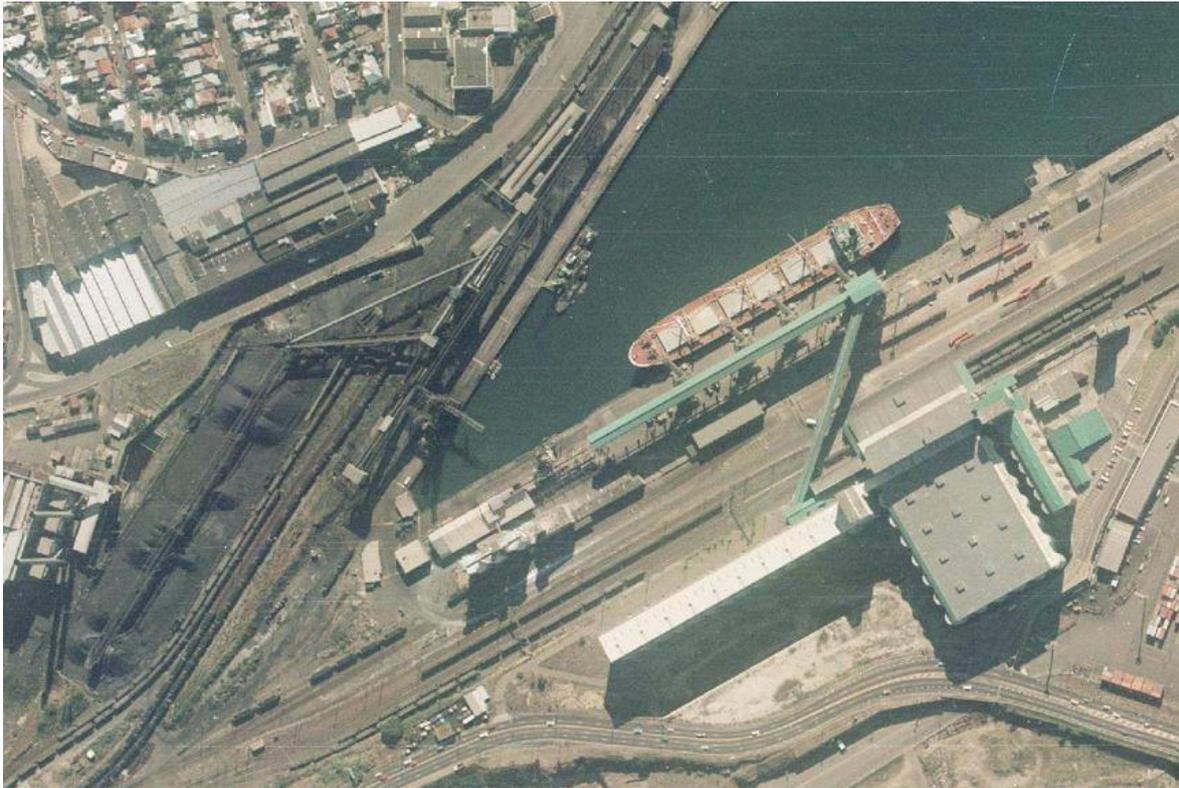
Figure 143: 3 August 1986 – The eastern portion of Shed No. 9 has been demolished and Balmain No. 1 Wharf connected with the container terminal further north-east (at top centre). This photograph suggests that the wharves in the eastern portion (on right) were shortened by then, involving removal of the deck. Source: NSW Spatial Services, Historical Imagery

and the bulk terminal wharf and bagging facility at Glebe Island, was sold to Penrice Soda Products Pty Ltd in 1989 which continued to operate the facility.³⁴⁷ By 1986, changes had been made to eastern portion of the wharves on the northern side of Glebe Island, where a section of the wharf deck appears to have been removed to the east of Berth 8 (Figure 143).

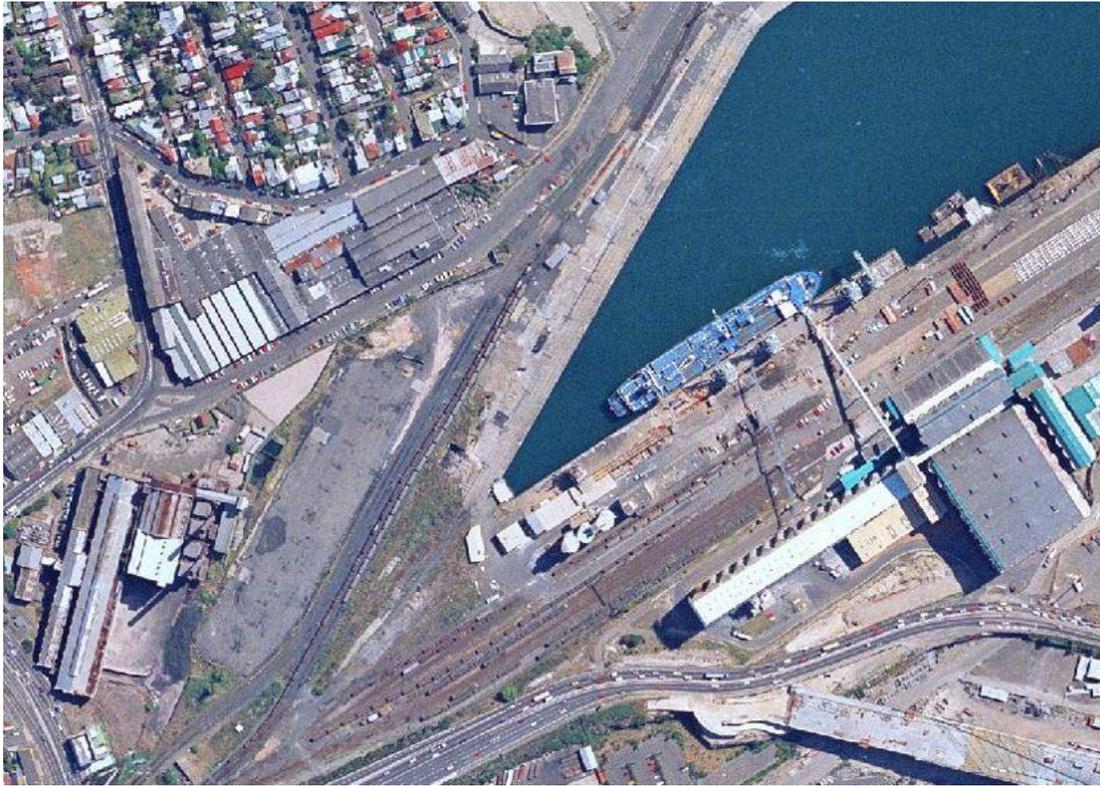
Figure 145: 4 October 1994 – The 1970s conveyor belt and loading facility at Glebe Island has been demolished and replaced. Note the cleared area behind Balmain No. 1 Wharf, where formerly the coal stacking area was located, on left. Source: NSW Spatial Services, Historical Imagery

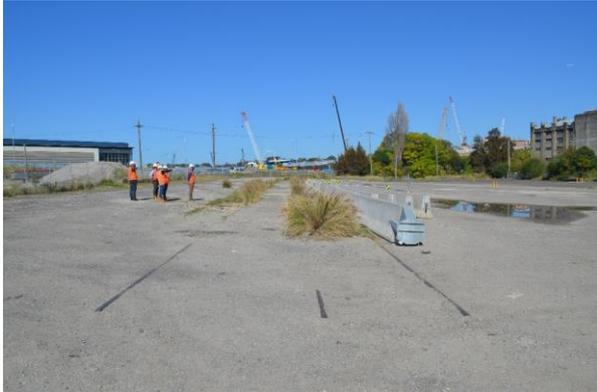
Figure 158: View of area of cleared ground for former stockpiling works, Port Access Road embankment with new stormwater outlet visible in background. East aspect.

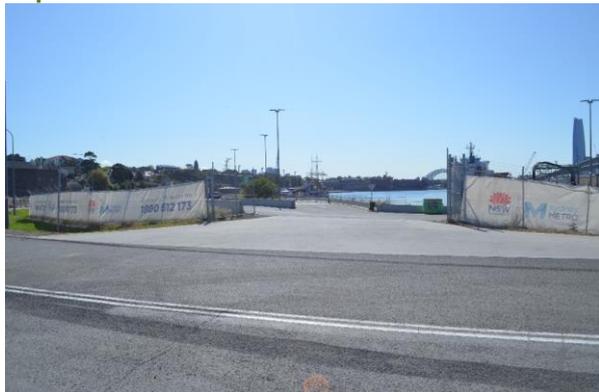
Figure 162: View of outlet canal metal plates and protective fencing. South aspect.

The southern outlet for the Outlet Canal of the water circulating system for White Bay Power Station is located within the construction site, approximately 30 m northeast of the western end of the bay. This consists of precast concrete abutments flanking the underground canal exit point at water level. The outlet has large, rusted steel access plates over the top of it and is fenced off from pedestrian access.

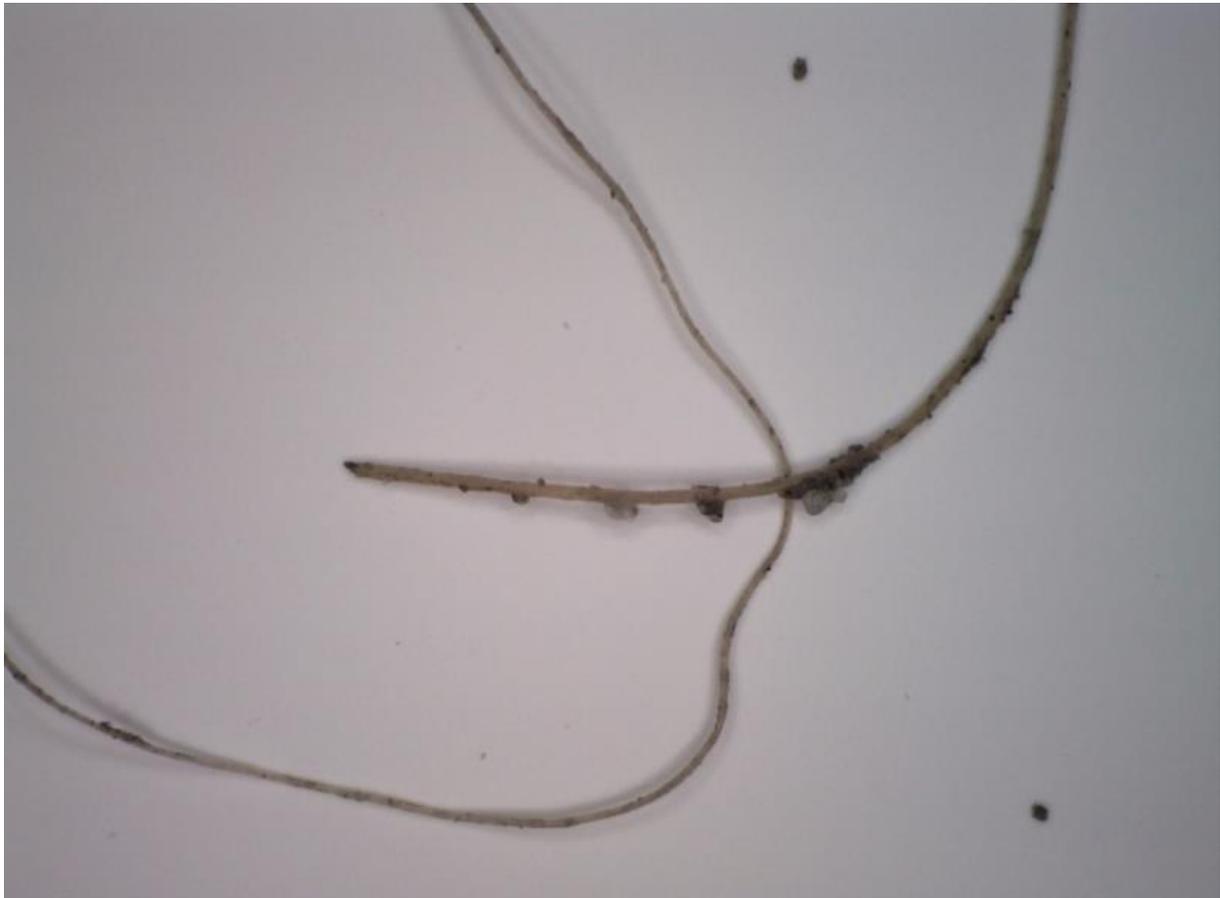
Figure 163: Micrograph of suspected cow fur identified in geotechnical soil deposits, at low (x50) power.³⁷⁶

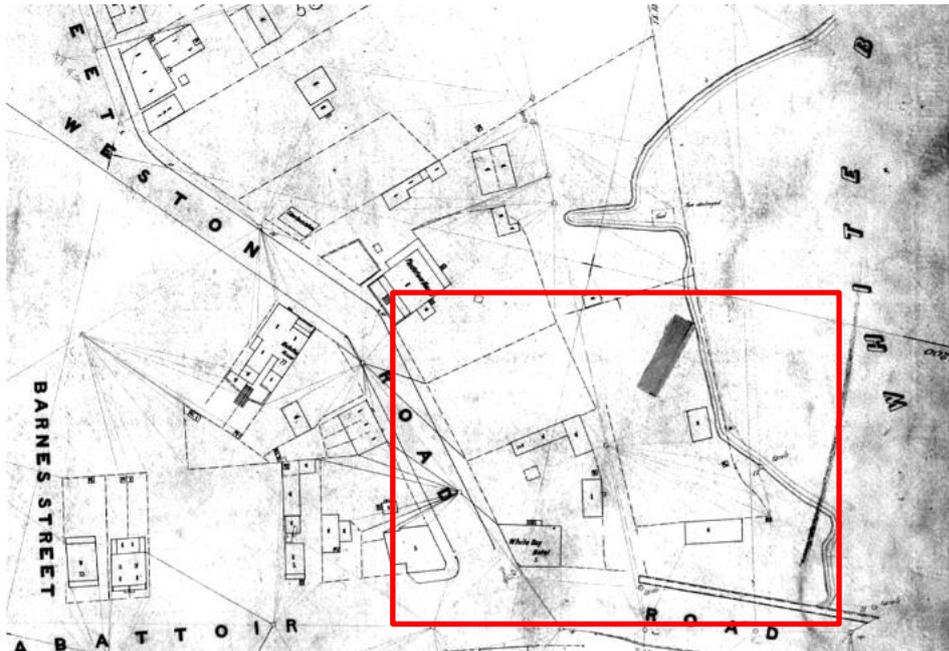
1888 Sydney Water Plan, showing White Bay Hotel on south-west corner of Weston Road and Abattoir Road, with outbuildings (stables, toilets) in rear.

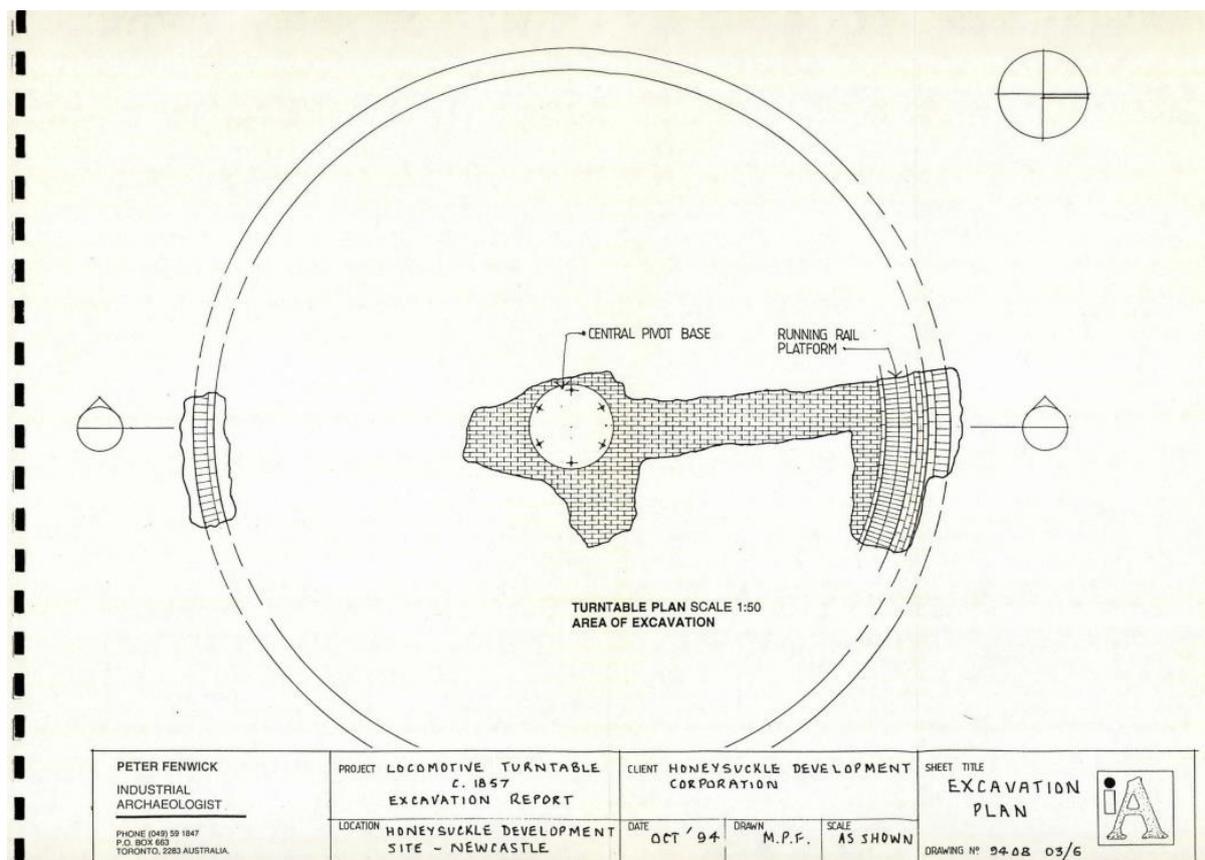
Figure 173: Honeysuckle turntable remnants (Source: Fenwick 1994).

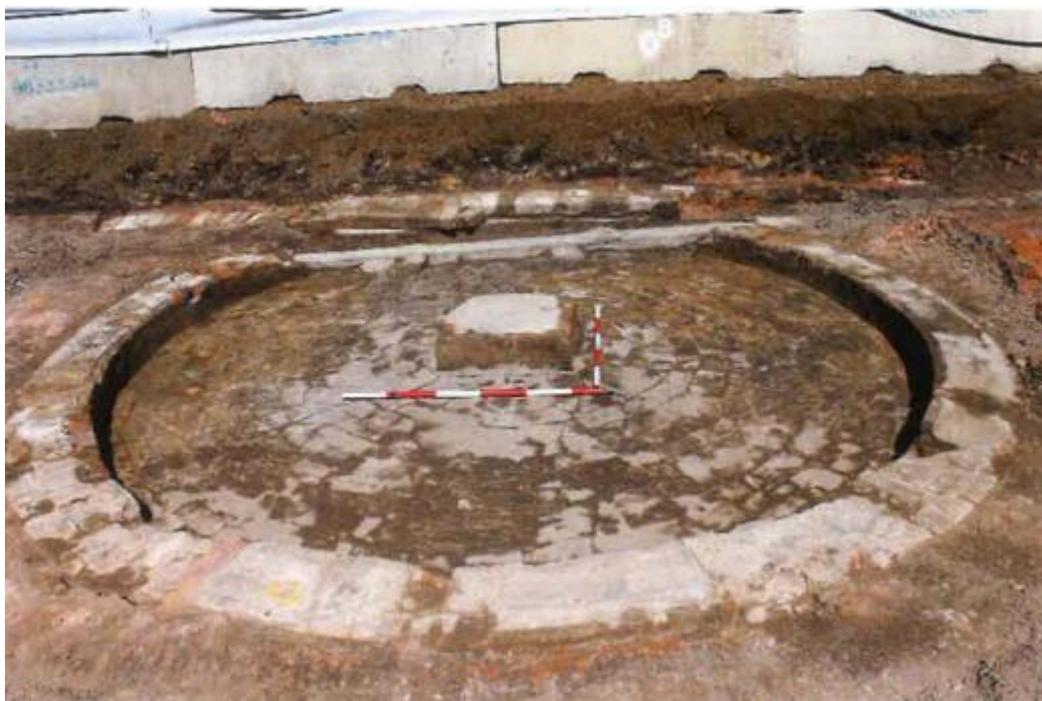
Figure 174: Lee Street turntable, with brick walls, floor and stone plinth still extant (Source: AMAC 2016).

Previous archaeological excavations have noted that the bricks used to surround turntable pits are often still present⁴²⁸. Such excavations have noted that the brick walls and floors of these pits have been discovered *in situ* despite being filled in and the area around them being disturbed and developed (Figure 173). Stone plinths, which were used to support the turntable and aided in its function, have also been noted, albeit far less frequently⁴²⁹ (Figure 174). Excavations of the Lee Street Substation also demonstrated patterns of cement bonding on the pit's brick walls that were associated with the turntable mechanisms⁴³⁰.

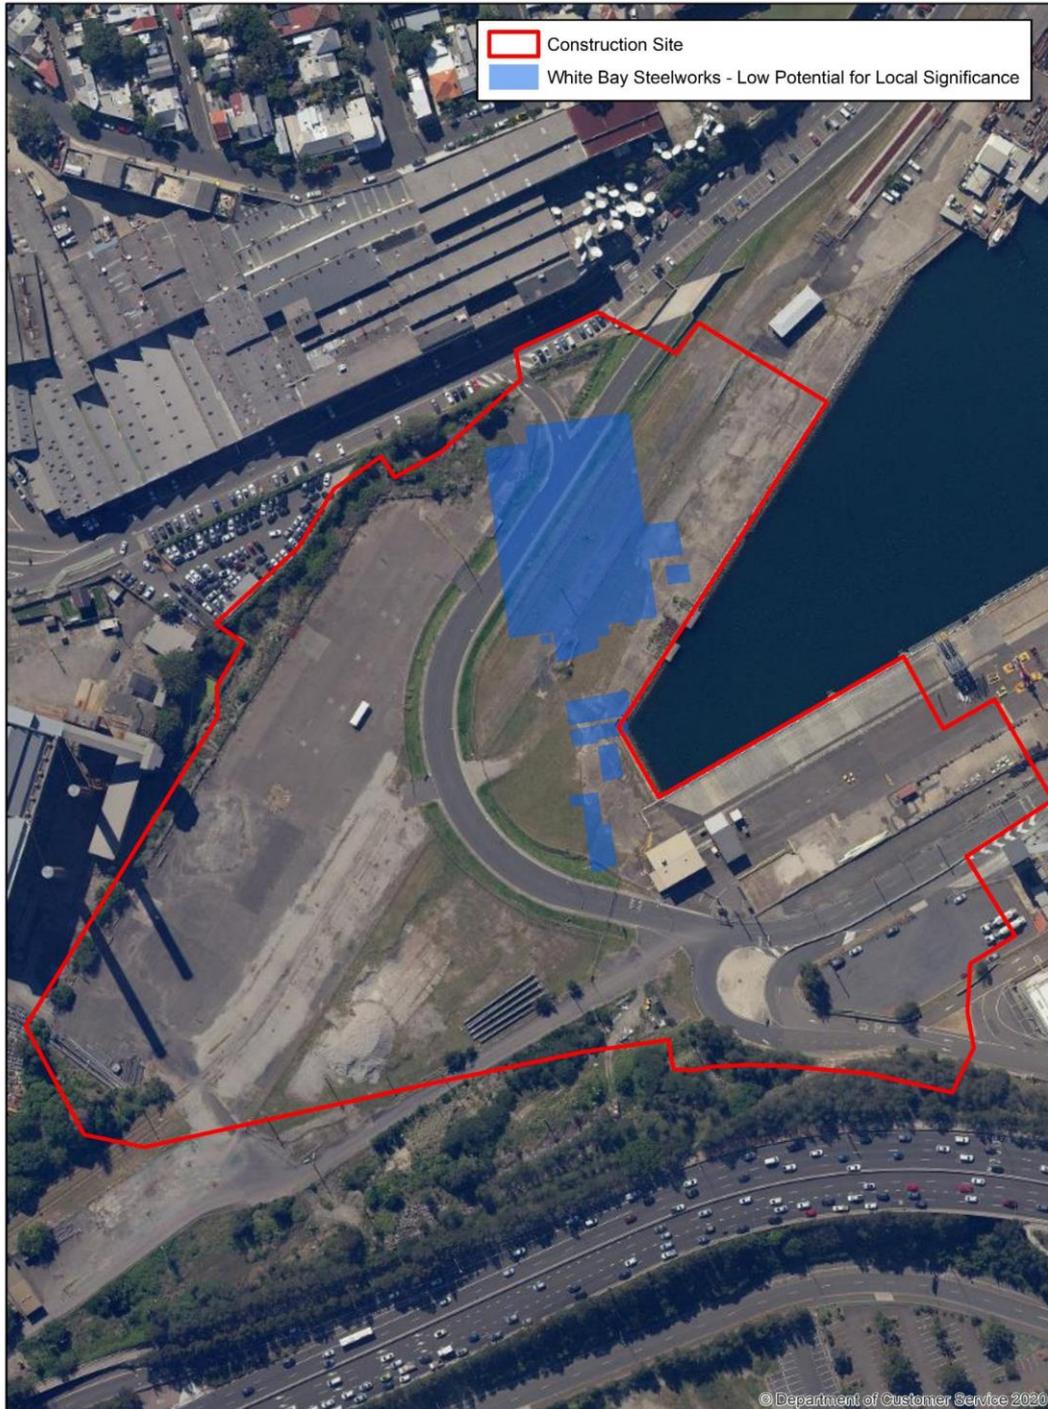
Figure 176: Archaeological site plan for White Bay Steelworks
